Old Field Point Lighthouse
Setauket - East Setauket, New York
REPORT OF INVESTIGATION
22 February 2022

INTRODUCTION

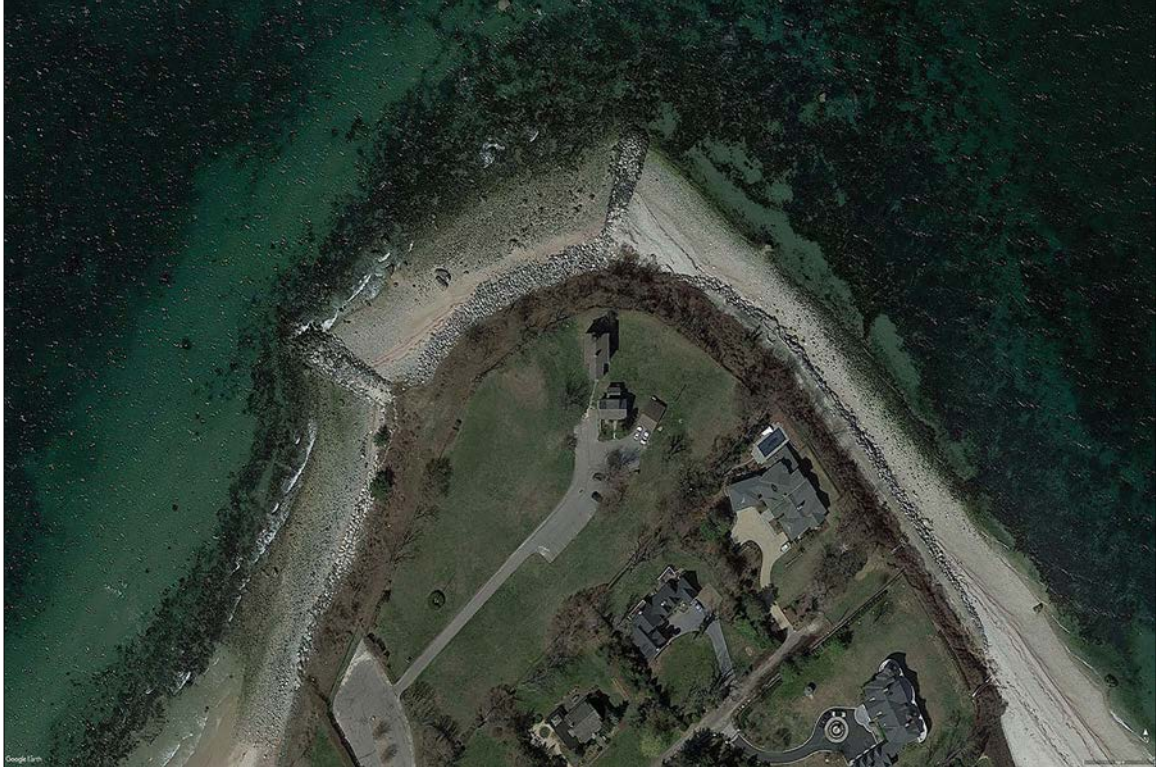
Photo 1. Old Field Point Lighthouse is oriented precisely on cardinal points: its tower faces due north.

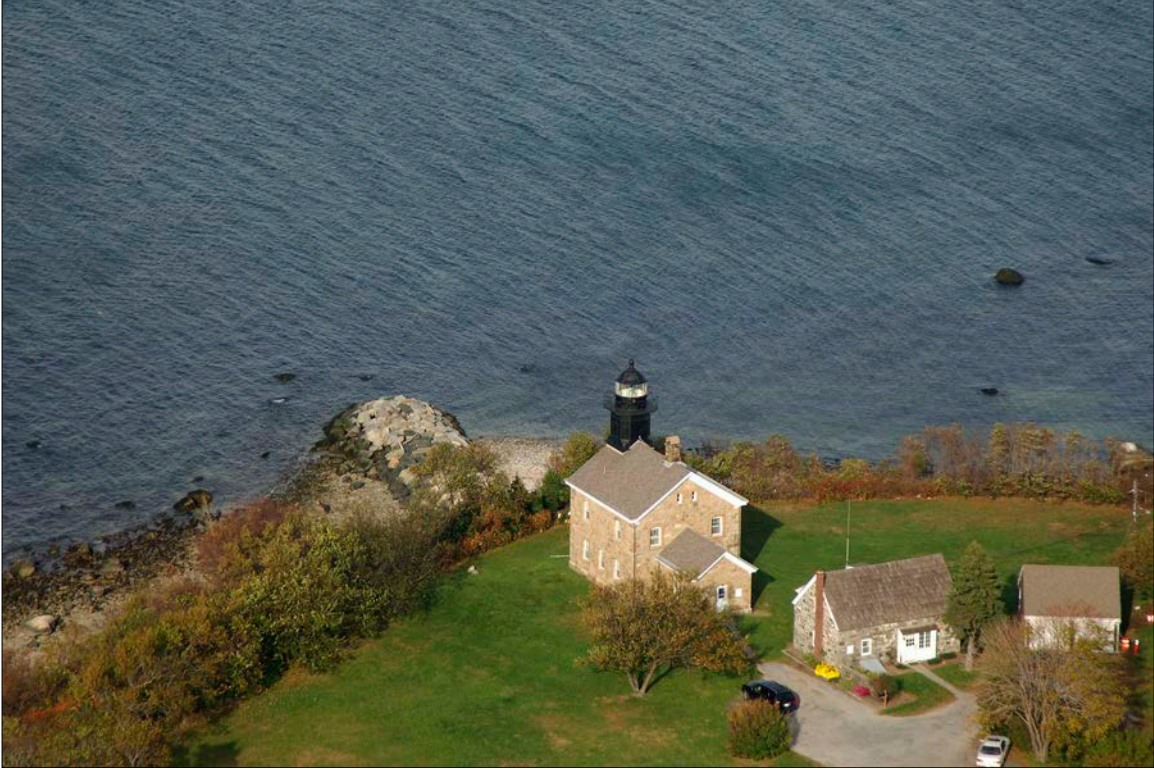
Photo 2. Aerial view northeast c.2021. Image © *marinas.com*.

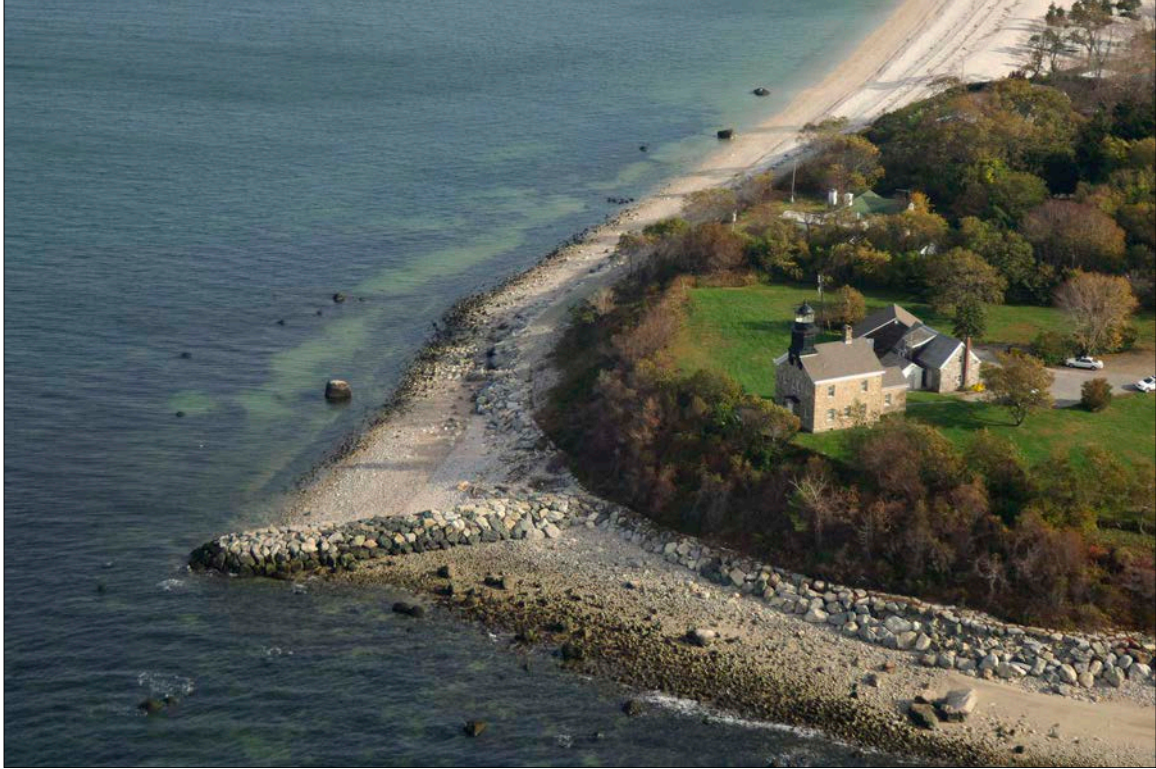
Photo 3. Aerial view southeast c.2021. Image © *marinas.com*.

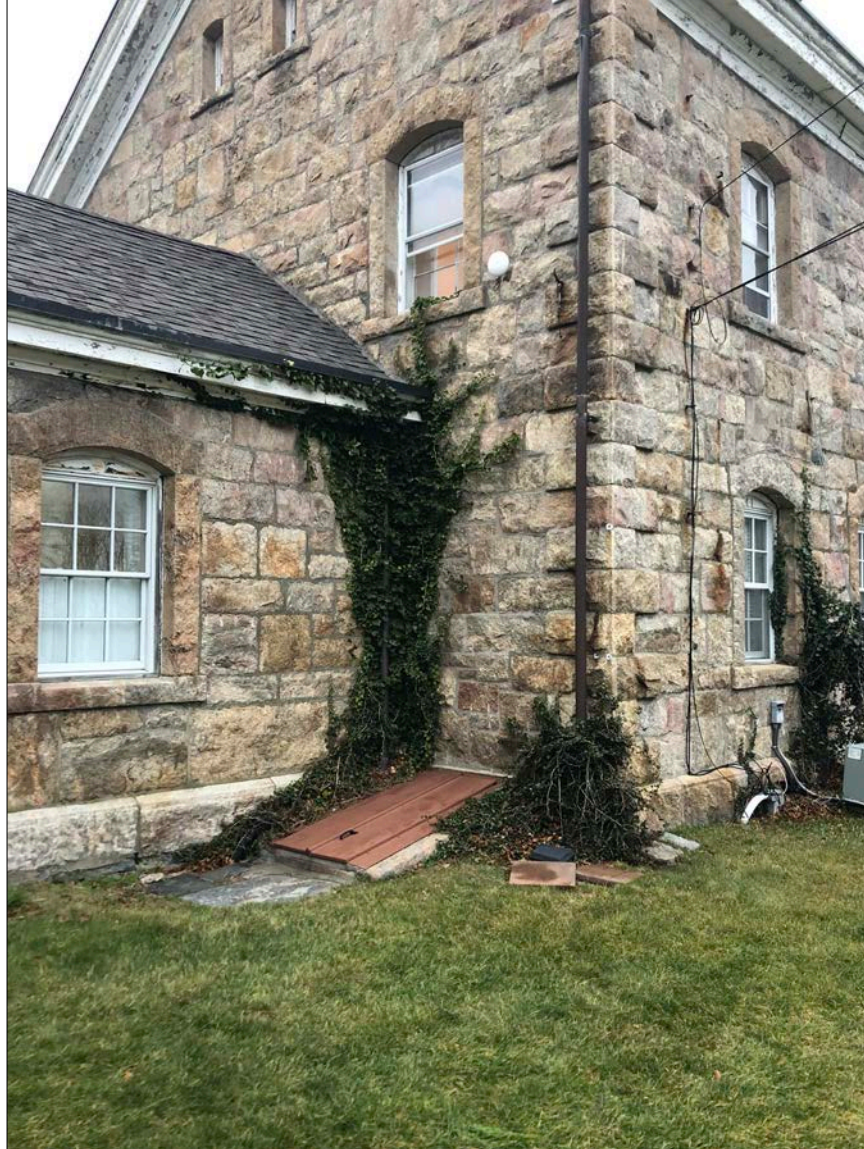
Photo 4. Stormwater collection and distribution systems are, generally, undersized and inadequately integrated. Subsurface drains are perhaps irredeemably clogged, resulting in water pooling at foundation, bulkhead stairs, and cellar door at base of bulkhead (adjacent to electrical panel). Rampant vegetative growth in southeast corner is supported by pooling water within the soil.

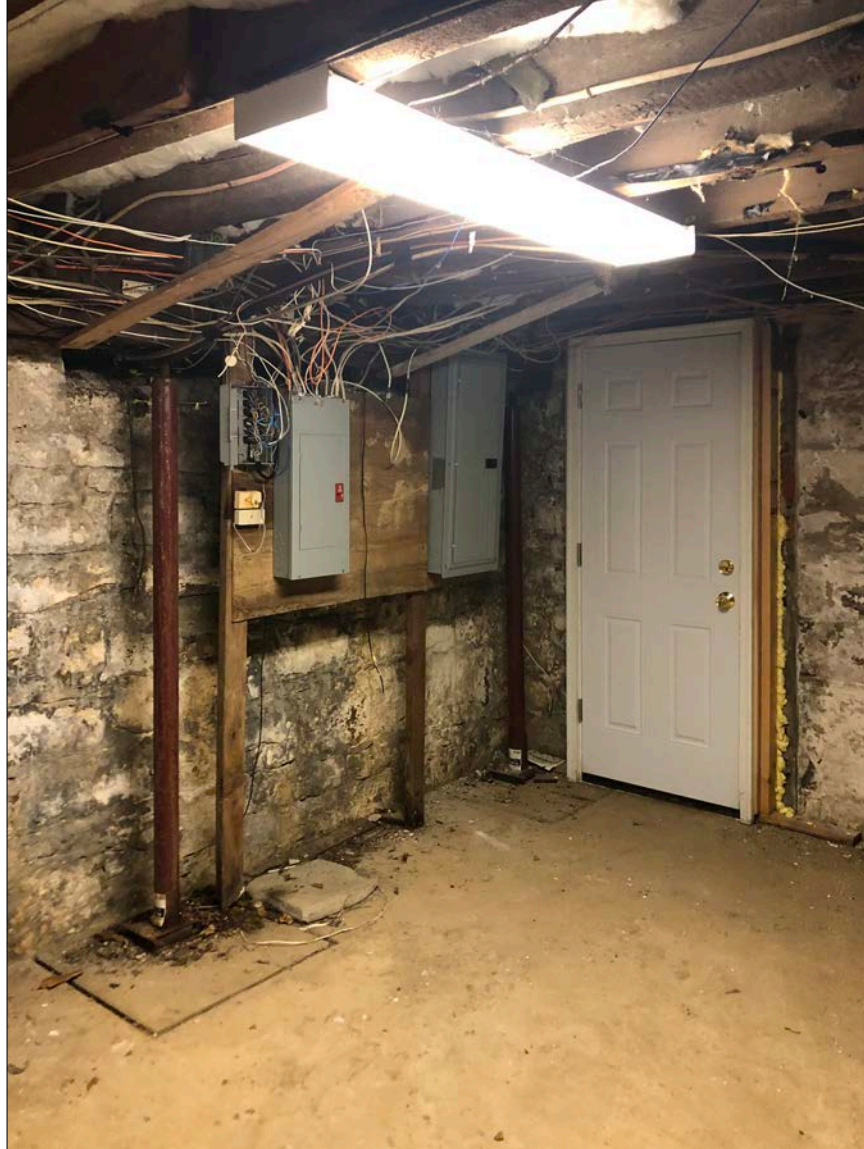
Photo 5. View to southeast within cellar, at the base of stairs within the bulkhead shown in prior photo. This area floods frequently. Current system of roof gutters, leaders & subsurface drains is both inadequate & corrupted.

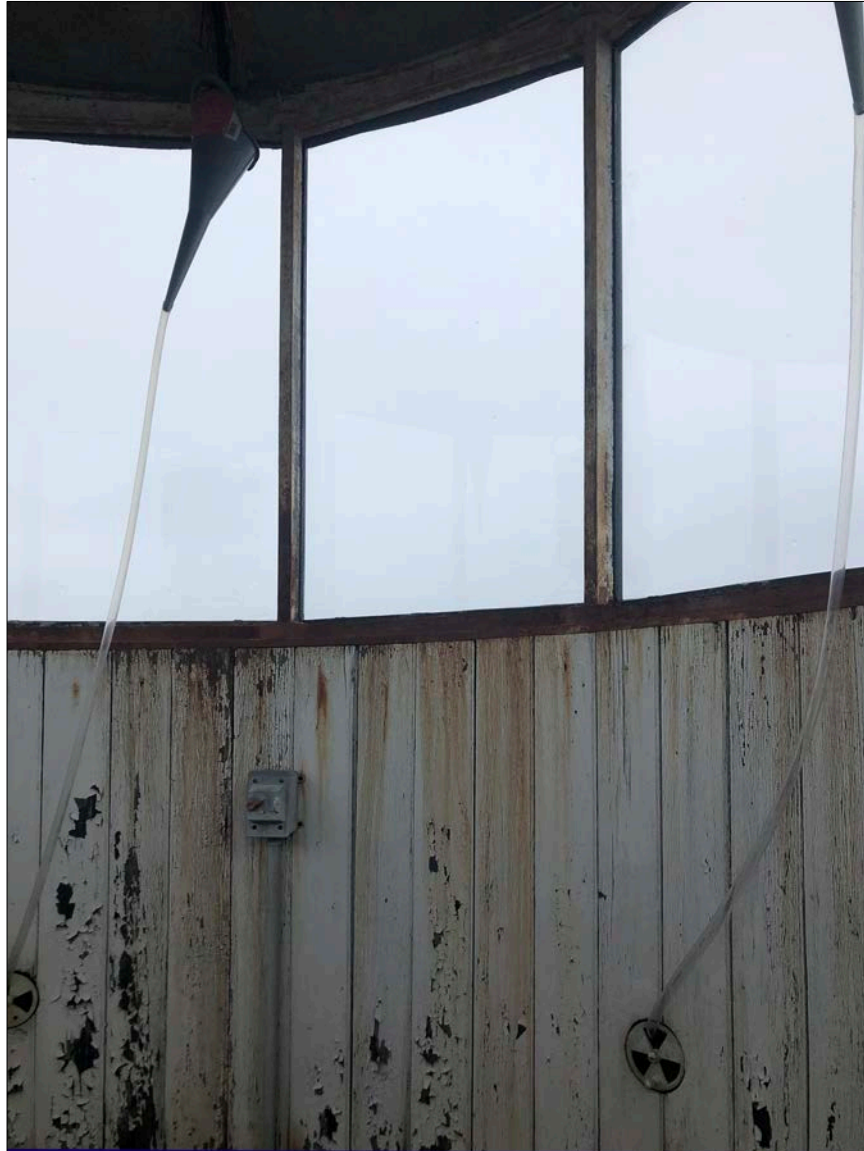
Photo 6. At the Lantern, an *ad hoc* system of funnels (6 total) collects rainwater from the interior of the cove, which is accessed via open joints of the ogee roof dome above. Water collected is channeled via clear tubing to the exterior deck of the Lantern Gallery, through the Lantern's air vents. This is neither a sustainable installation, nor effective: Properly repairing the roof and cove will keep rainwater out of the Lantern interior.

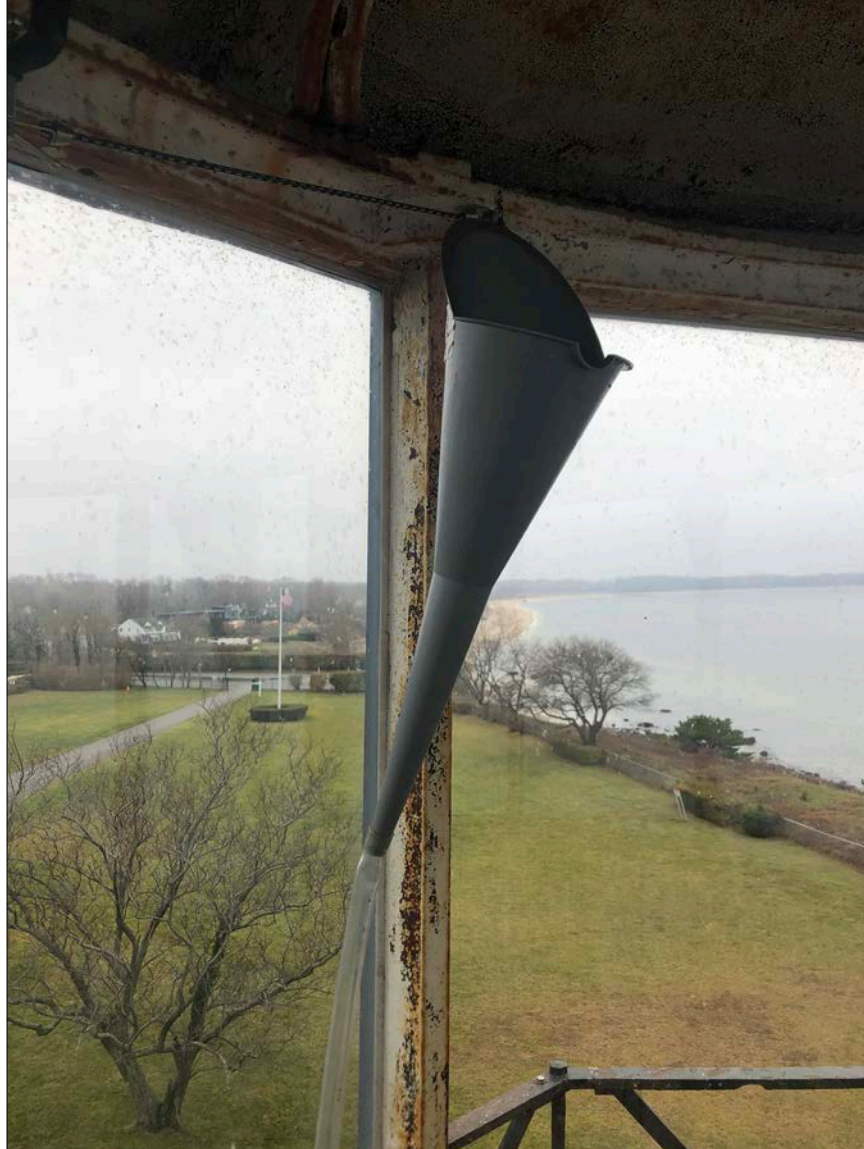
Photo 7. Detail of one of 6 funnels retrofitted to collect rainwater once it has penetrated the open joints of the Lantern roof.

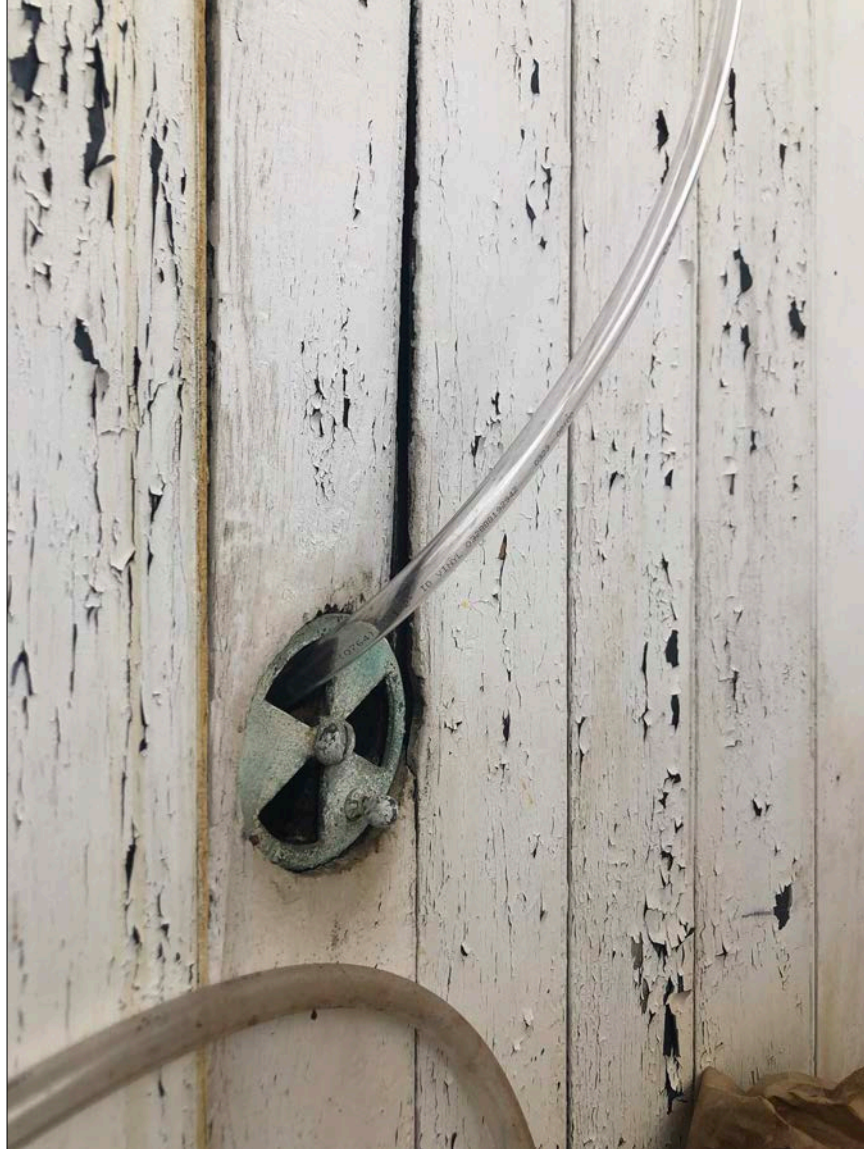
Photo 8. Detail of flexible tube routing rainwater collected from within the Lantern via funnels at the roof cove through the Lantern's original air vents (which, incidentally, were originally designed to regulate the lantern flame).

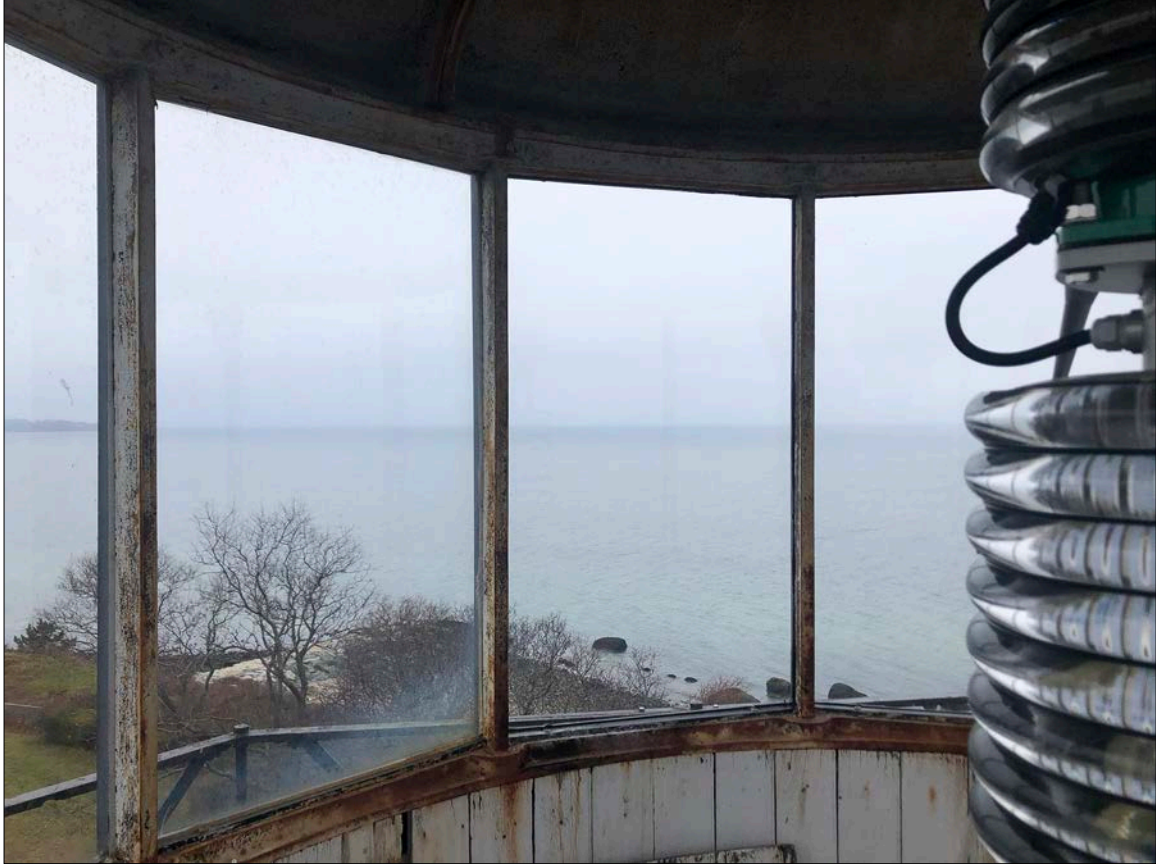
Photo 9. General view through Lantern of Long Island Sound, looking northwest, with upgraded LED Fourth Order Light in foreground. The Light's characteristic alternates red and green.

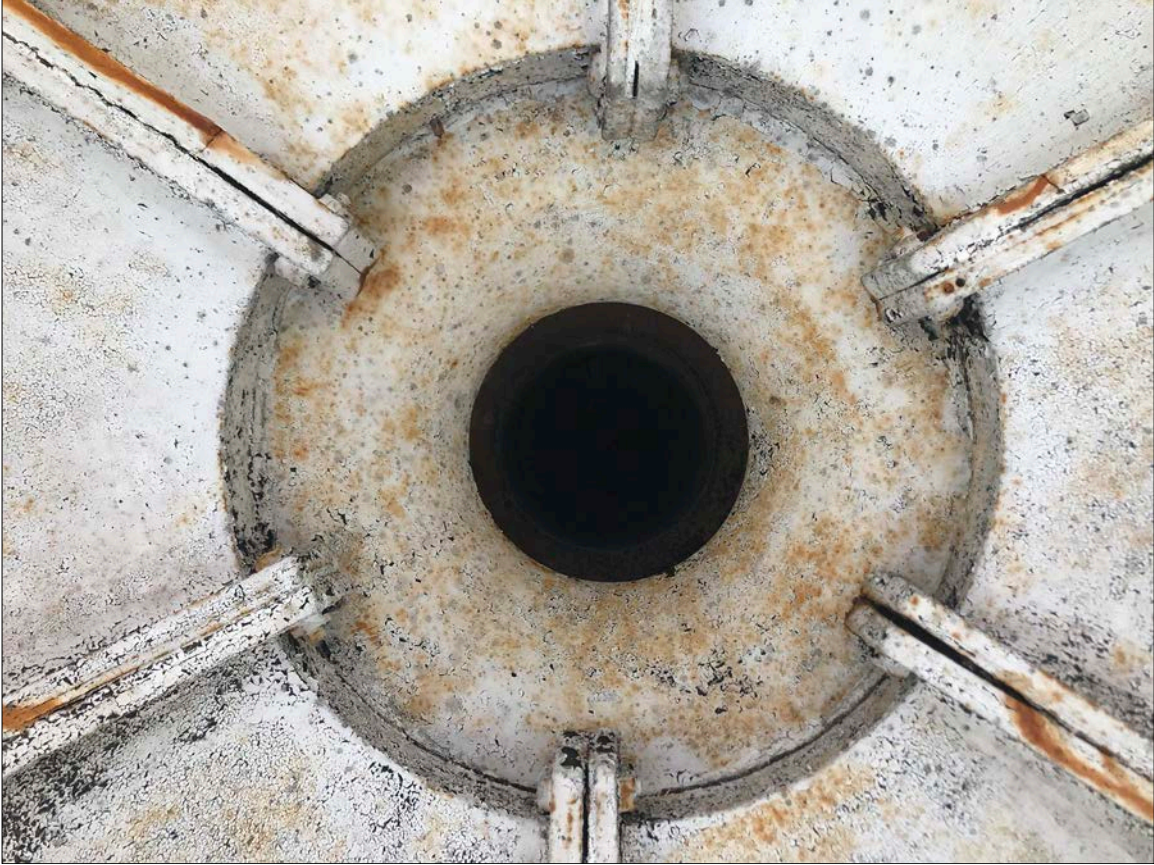
Photo 10. View to top of Lantern at culmination of the iron spider frame. The opening at center leads to the spherical vent ball mounted at the roof apex, which controls crucial convective air currents from grade to Lantern. This current continually refreshes the air at all levels of the Lighthouse.

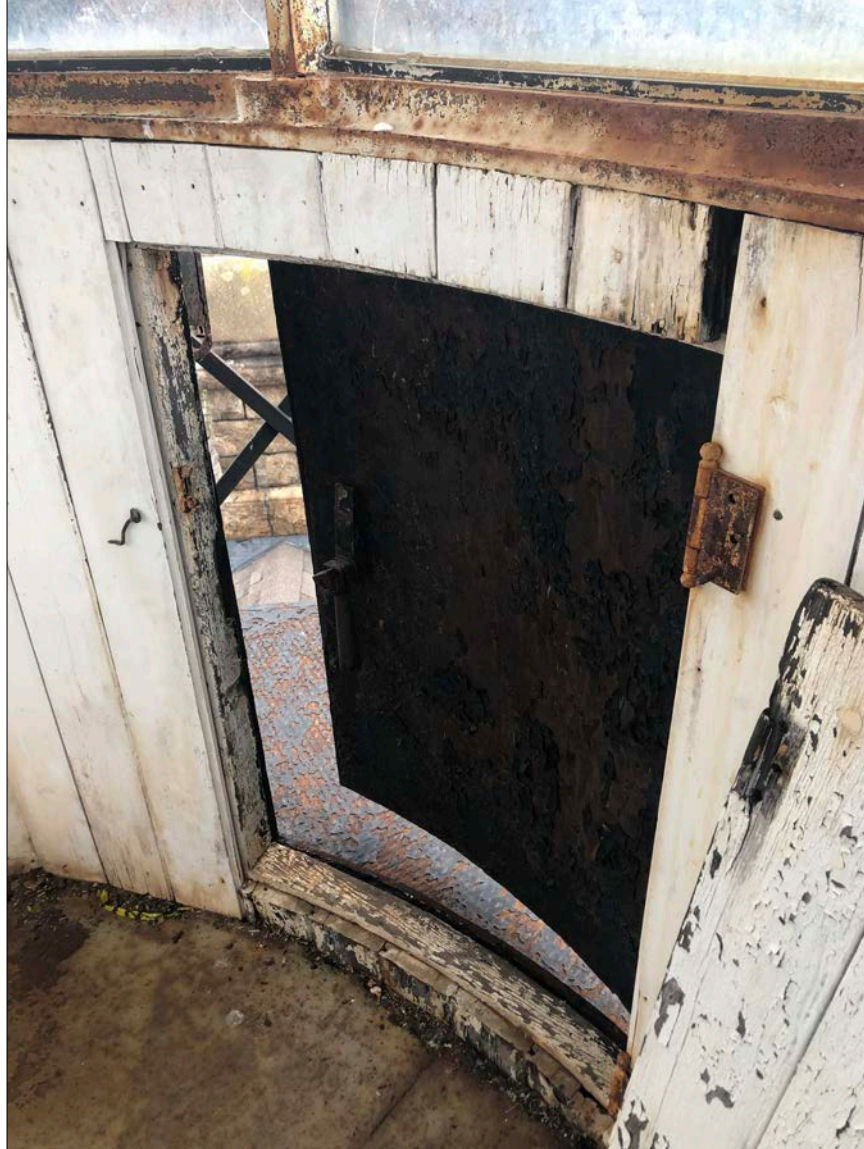
Photo 11. Lantern hatch to Lantern Gallery. This door is actually in sound working order fundamentally, although the application of inappropriate seals and deteriorating paint interferes with its smooth operation.

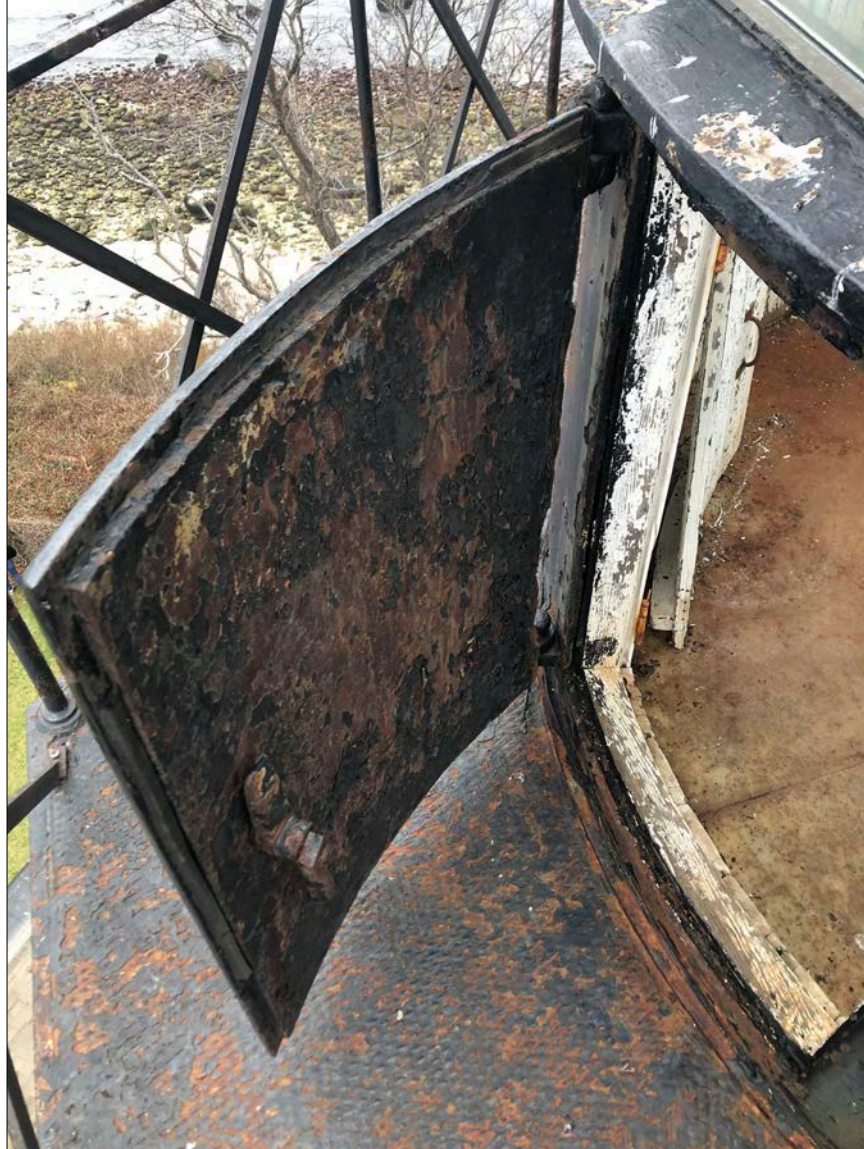
Photo 12. View of opened Lantern hatch, showing operation & hardware.

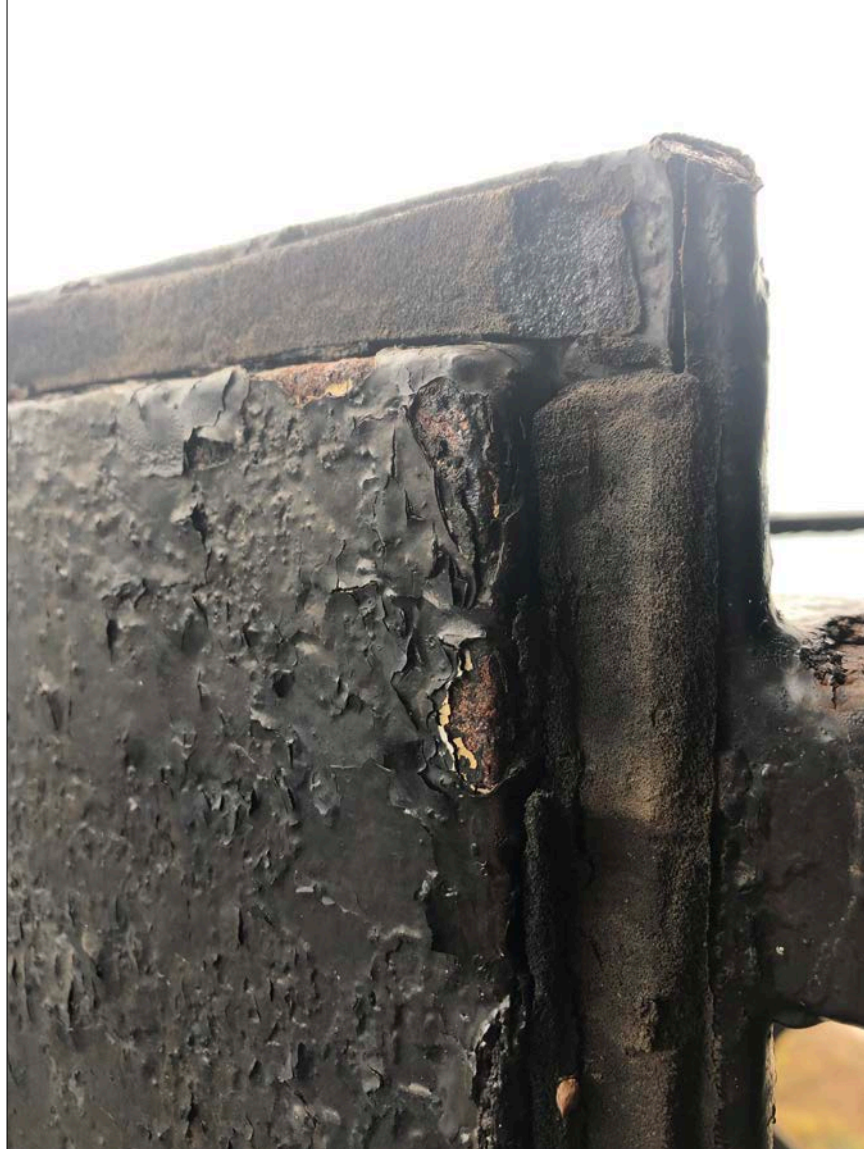
Photo 13. Detail of upper interior corner of cast iron hatch providing access from Lantern to Gallery. Note the addition of non-compressible perimeter seals as well as the build-up and deterioration of paint coatings.

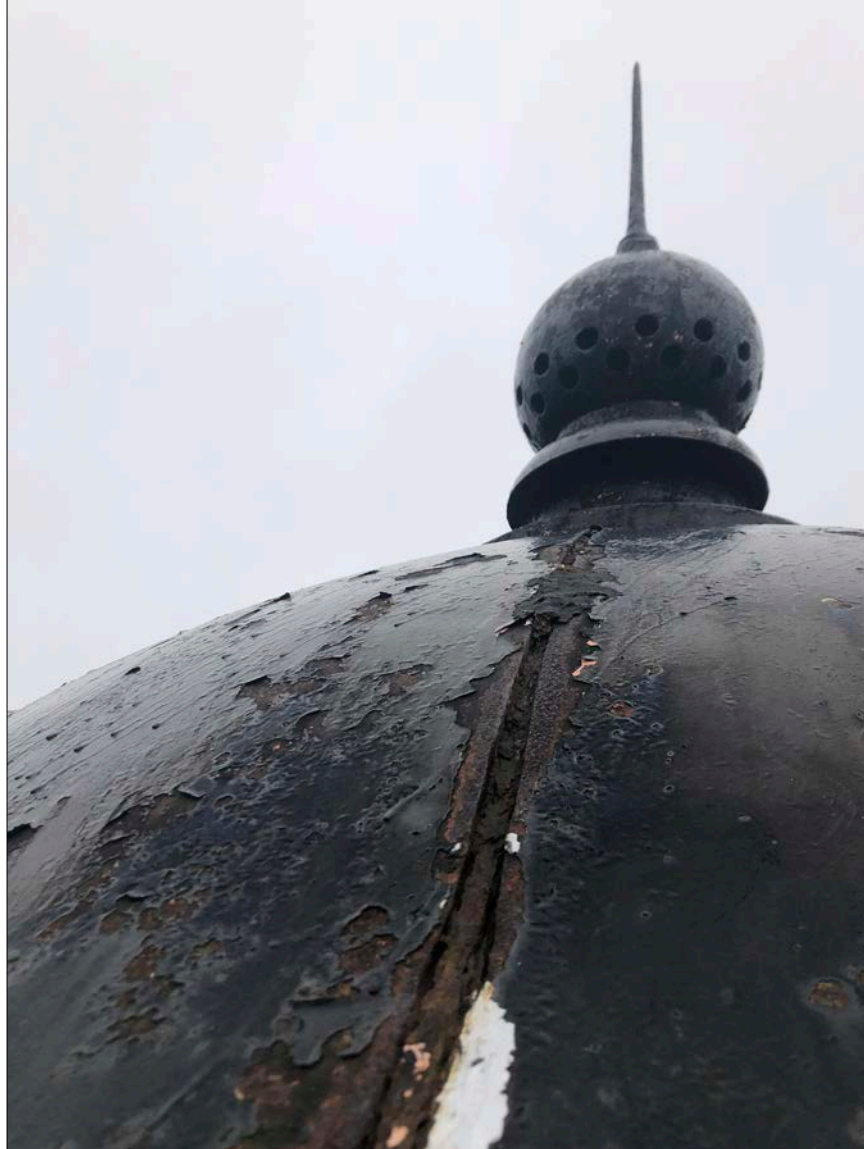
Photo 14. View of six-panel ogee dome atop Lantern, including ventilator ball. The original terminal is not connected to a lightning protection system. Open joints are severe and allow water to migrate into Lantern (leading to the funnel & tube collection apparatus at the interior cove); joints, surfaces and features of this roof are all imminently restorable.

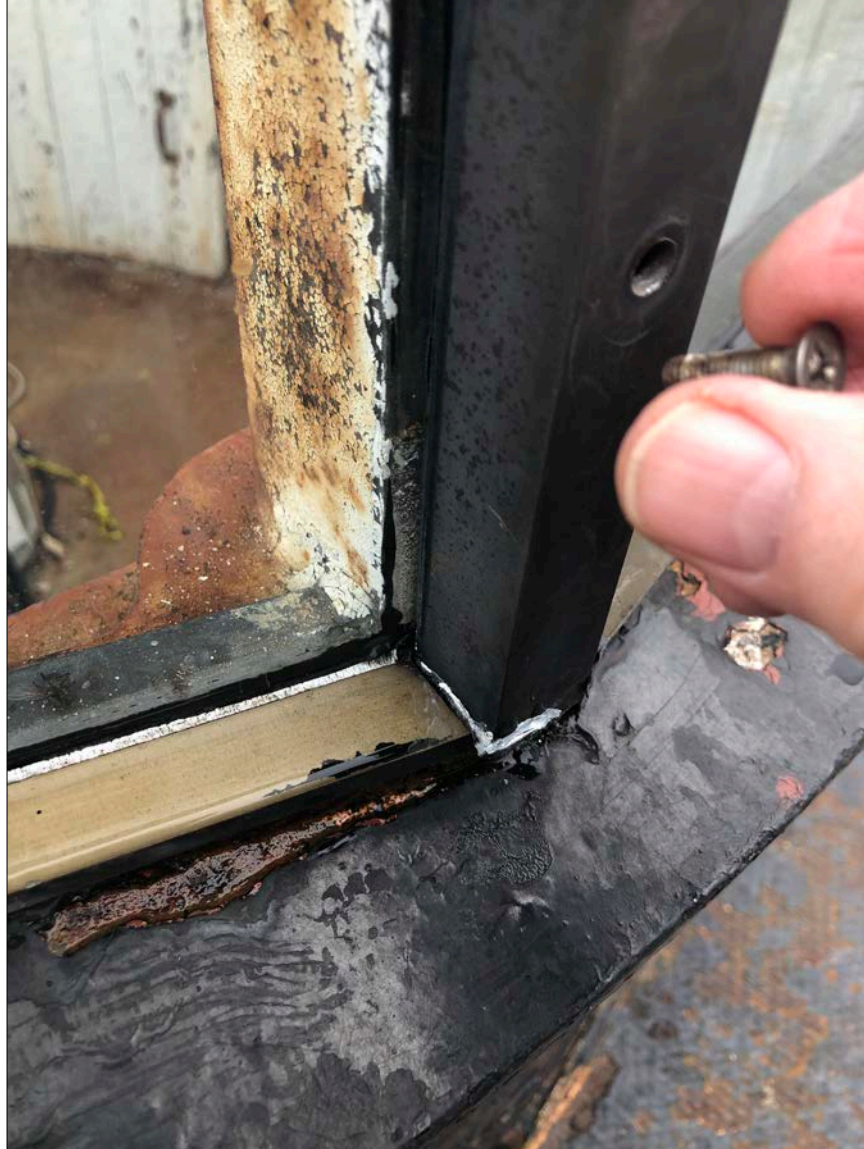
Photo 15. The original Lantern frame incorporates a superlative glazing bar system. Aluminum panning over the original glazing bars might have the appearance of an upgrade, but is corrosive to the underlying original system. It introduces a dissimilar metal (potentially producing a galvanic reaction), hides the condition of the original, relies only on weak sealants at corners, and is not secured to the underlying structure (the screw indicated – one of many – is just placed in the hole for show, not actually fastened to anything).

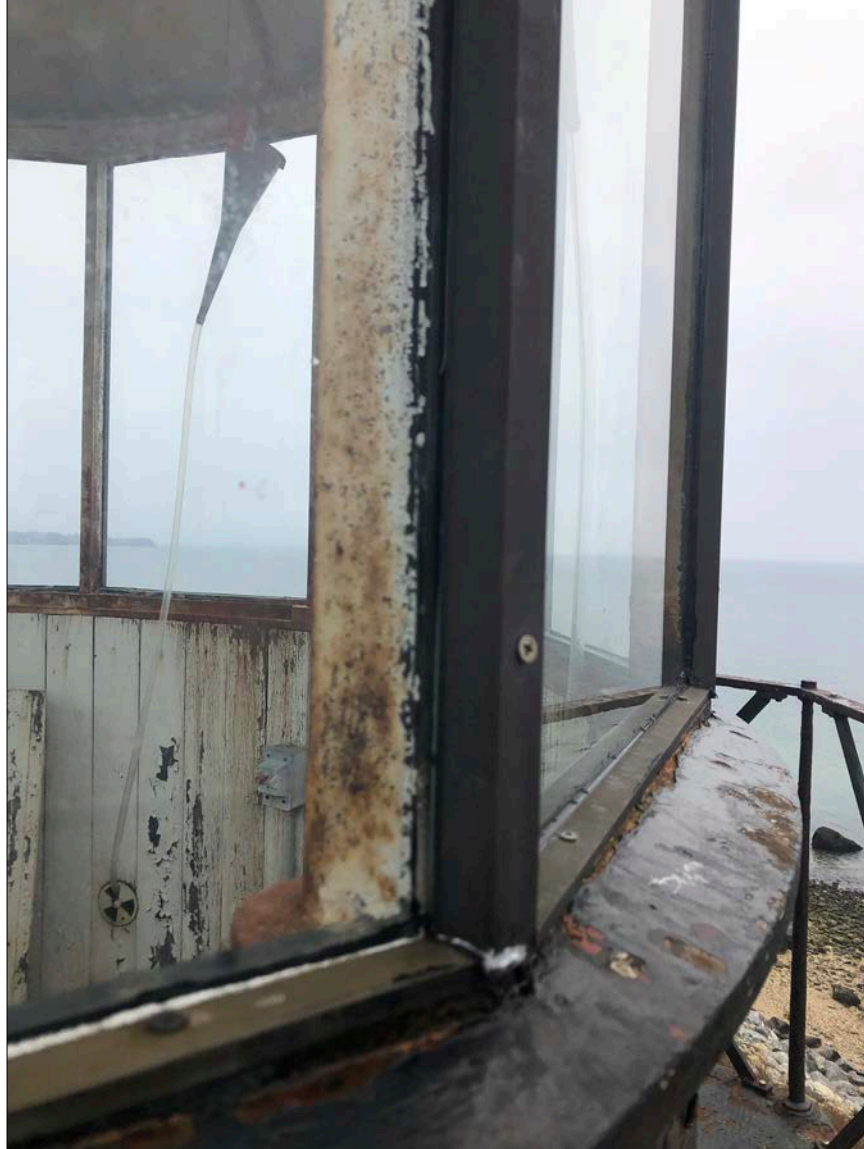
Photo 16. General view through exterior lantern glazing, looking northwest.

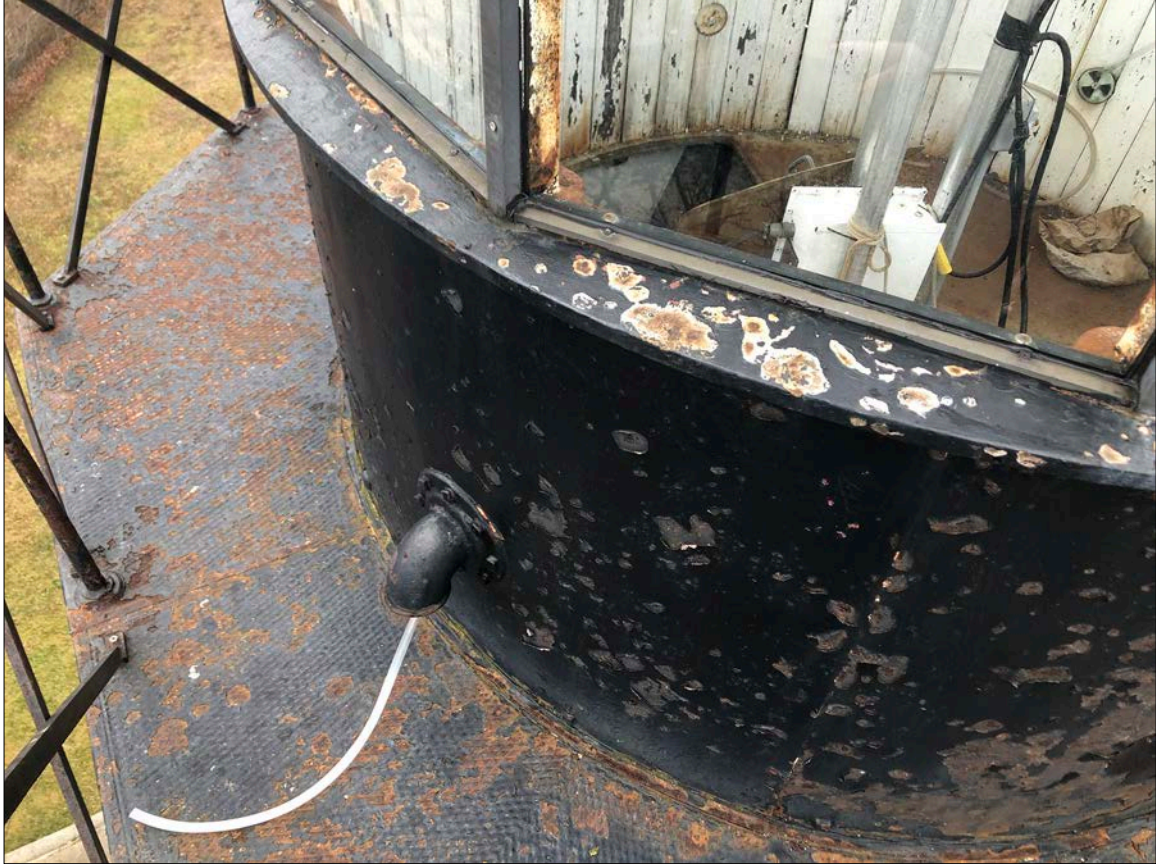
Photo 17. Lantern Gallery embossed decking, original circular drum and sill, modified railings. Note flexible tube from funnel collection system protruding through original air vent terminus.

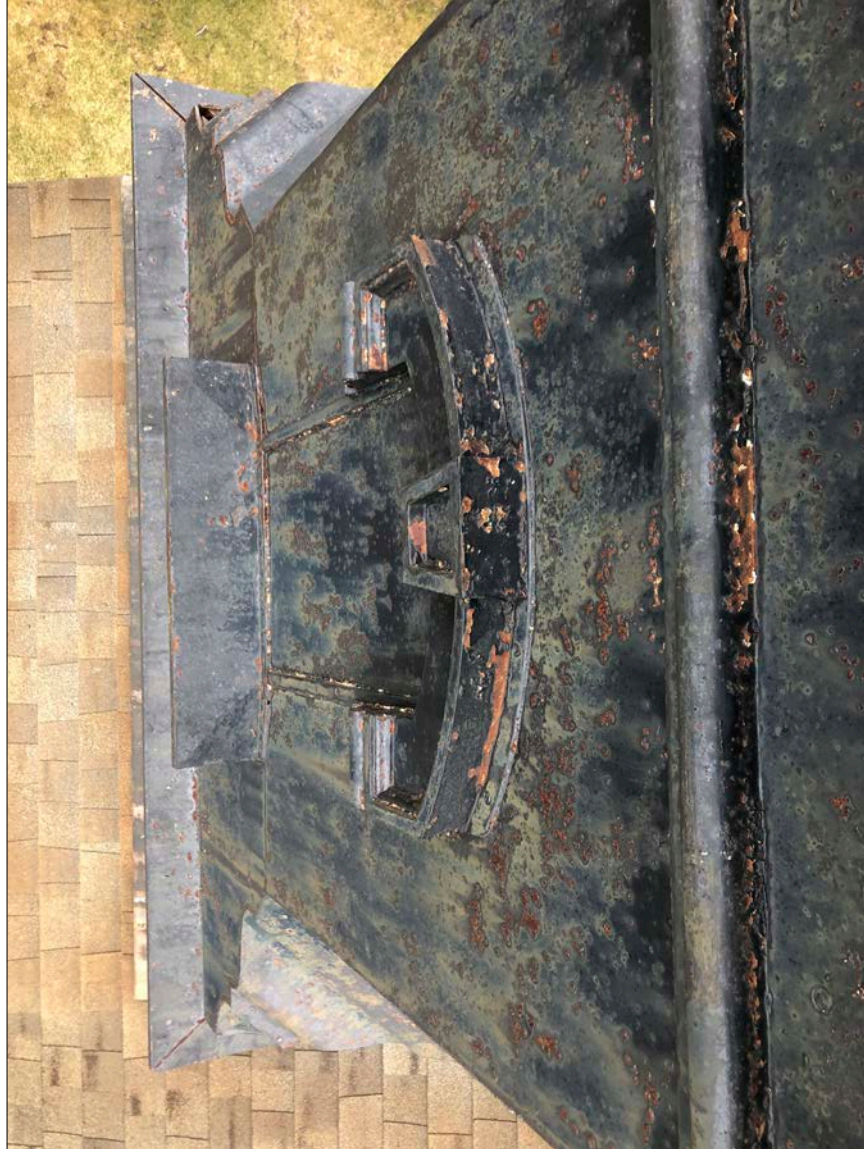
Photo 18. Looking down from Lantern Gallery, over railings. The condition of the Service Level facade plates, blind window hood & sill, and dated breastplate beneath them are in superlative condition. There are, however, significant breaches in the fascia directly under the Gallery, a particularly weak point for weathertight integrity, particularly when facing the direct brunt of salt laden storm water and high winds. All of it is readily restorable.

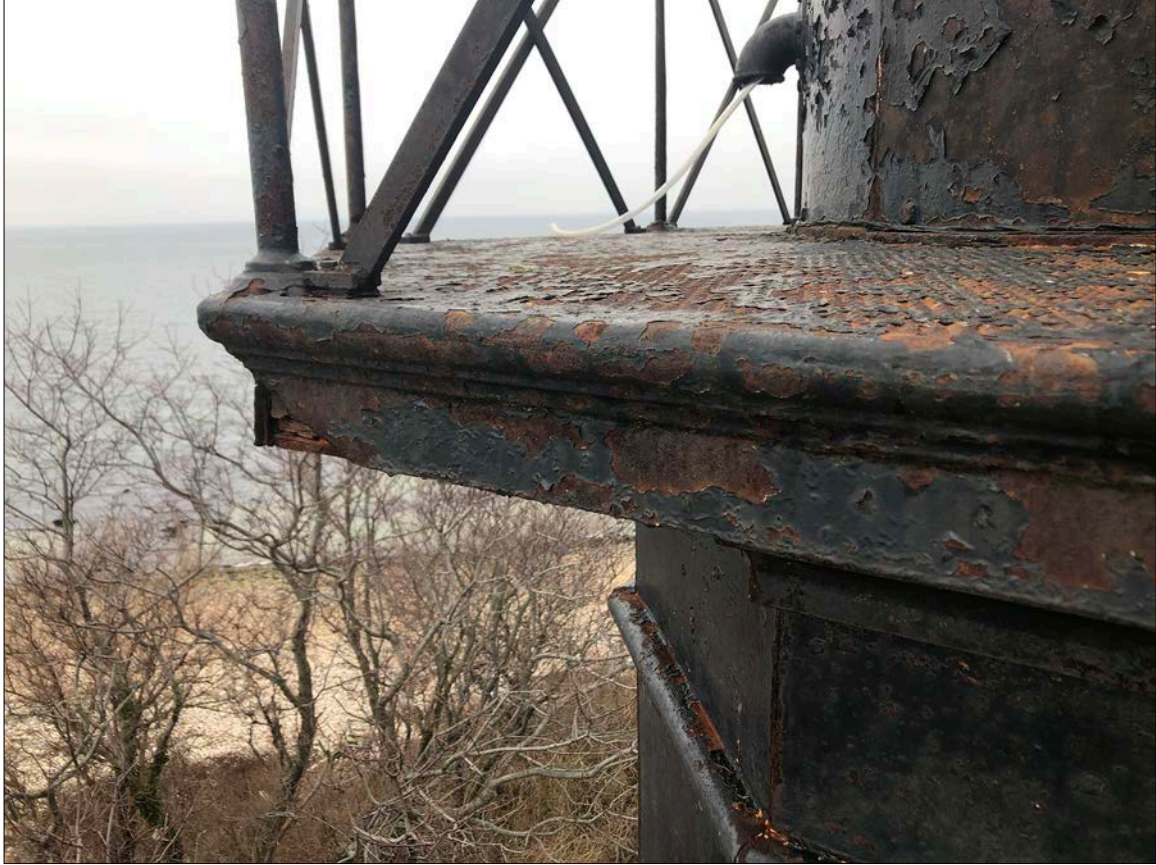
Photo 19. View of Watch Deck fascia, looking northeast. Note deep corrosion at miter on left, which corresponds to the rail anchors, and their relative watertight integrity.

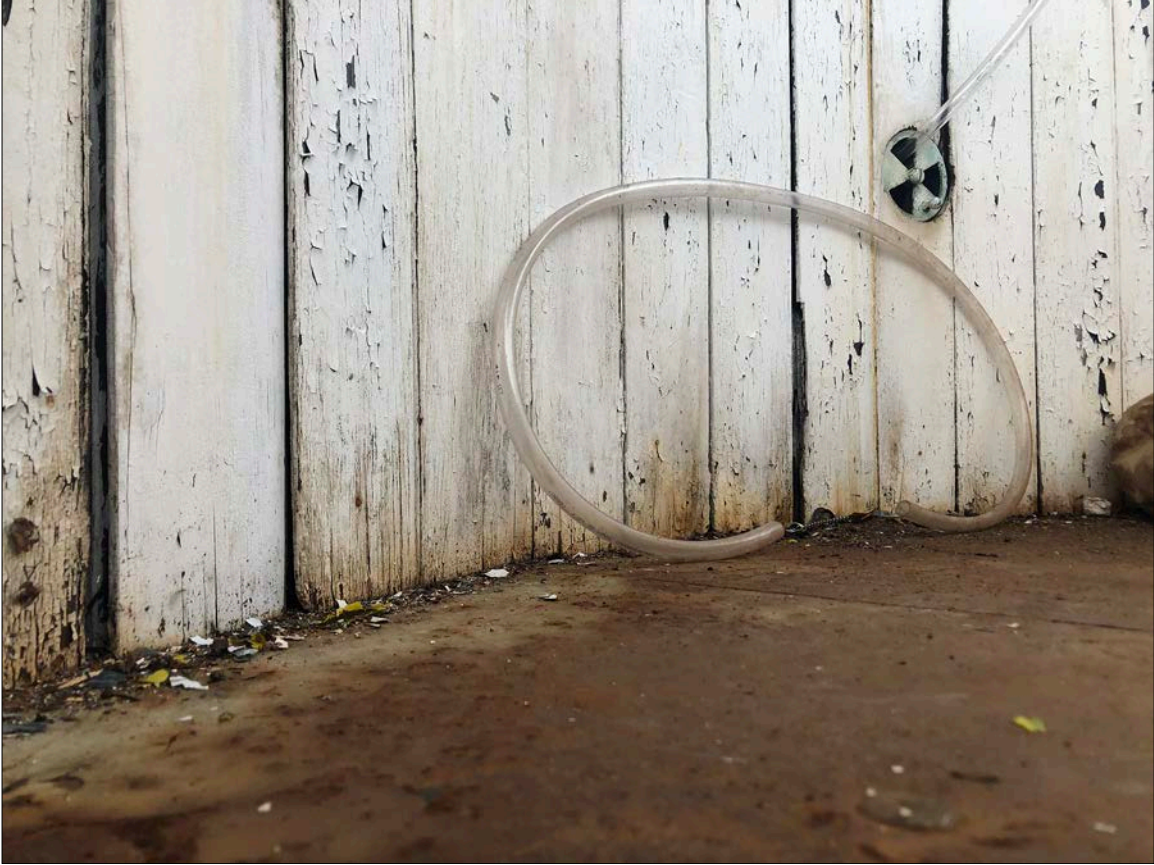
Photo 20. Interior Lantern drum vertical tongue-and-groove paneling. The end grain of wood readily absorbs water/moisture, and is where pathologies of deterioration often begin. Note the damage to paint associated with end grain at the base of the paneling.

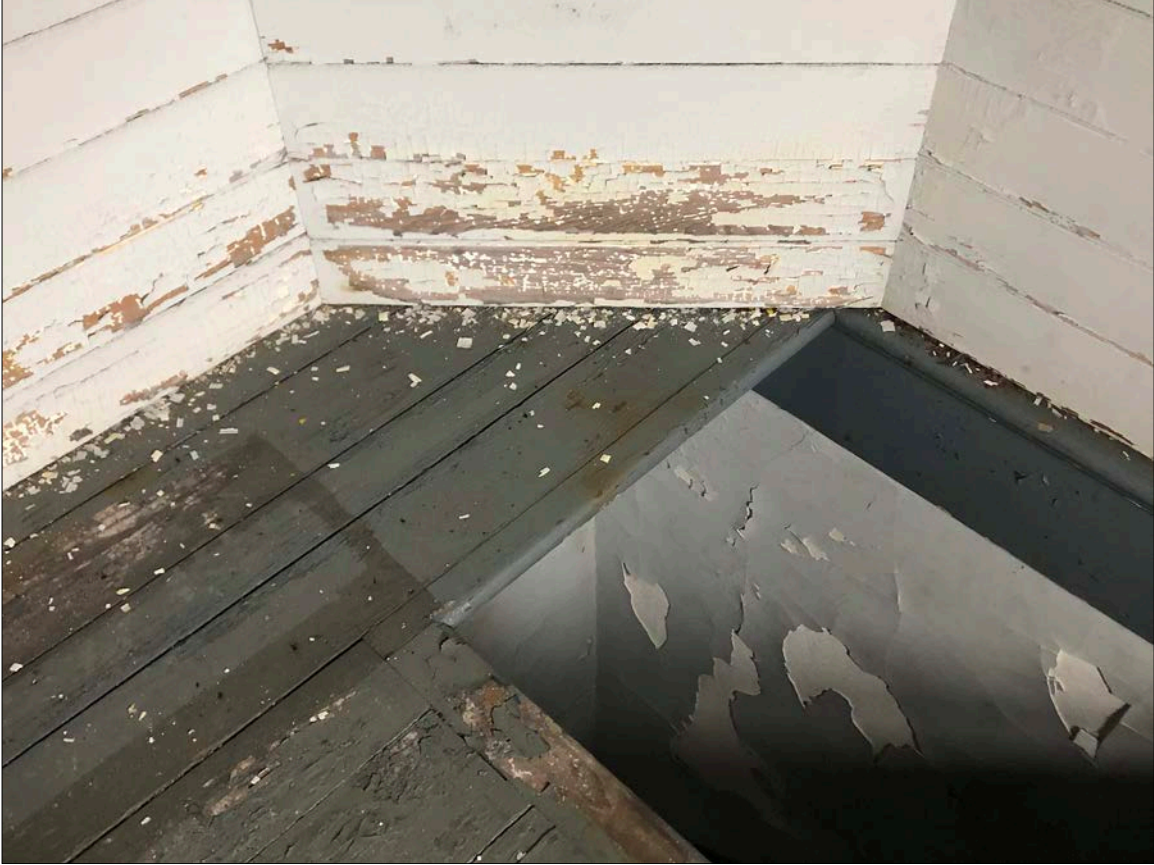
Photo 21. Horizontal tongue-and-groove paneling of the Service Level, which is bound by cast iron facade plates. Paint loss is indicative of moisture collecting behind the paneling; water likely accesses this location from the vicinity of the Watch Deck level above.

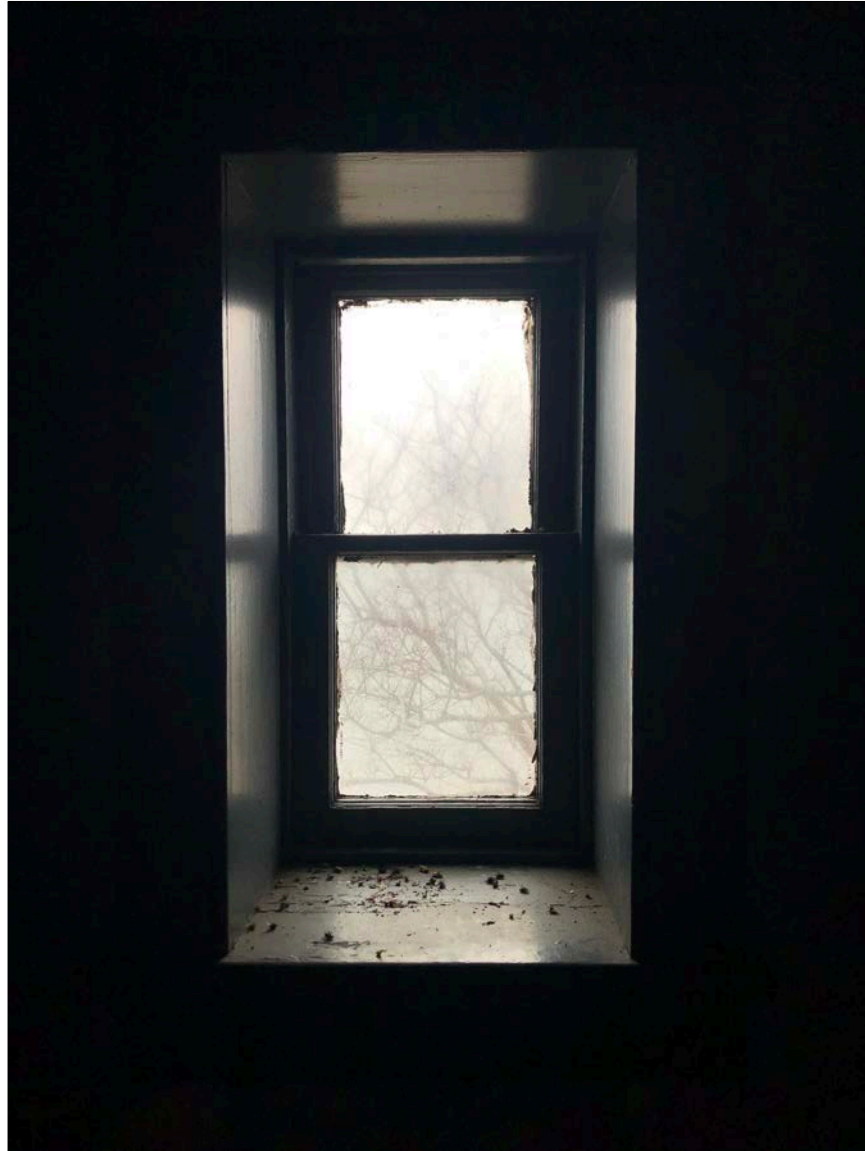
Photo 22. The original cast iron Service Level single hung window, readily seen on the Tower facade. The window remains in superlative condition, though deterioration of coatings, surface corrosion and lack of use have rendered it presently inoperable.
