Old Field Point Lighthouse
Setauket - East Setauket, New York
REPORT OF INVESTIGATION
22 February 2022

INTRODUCTION

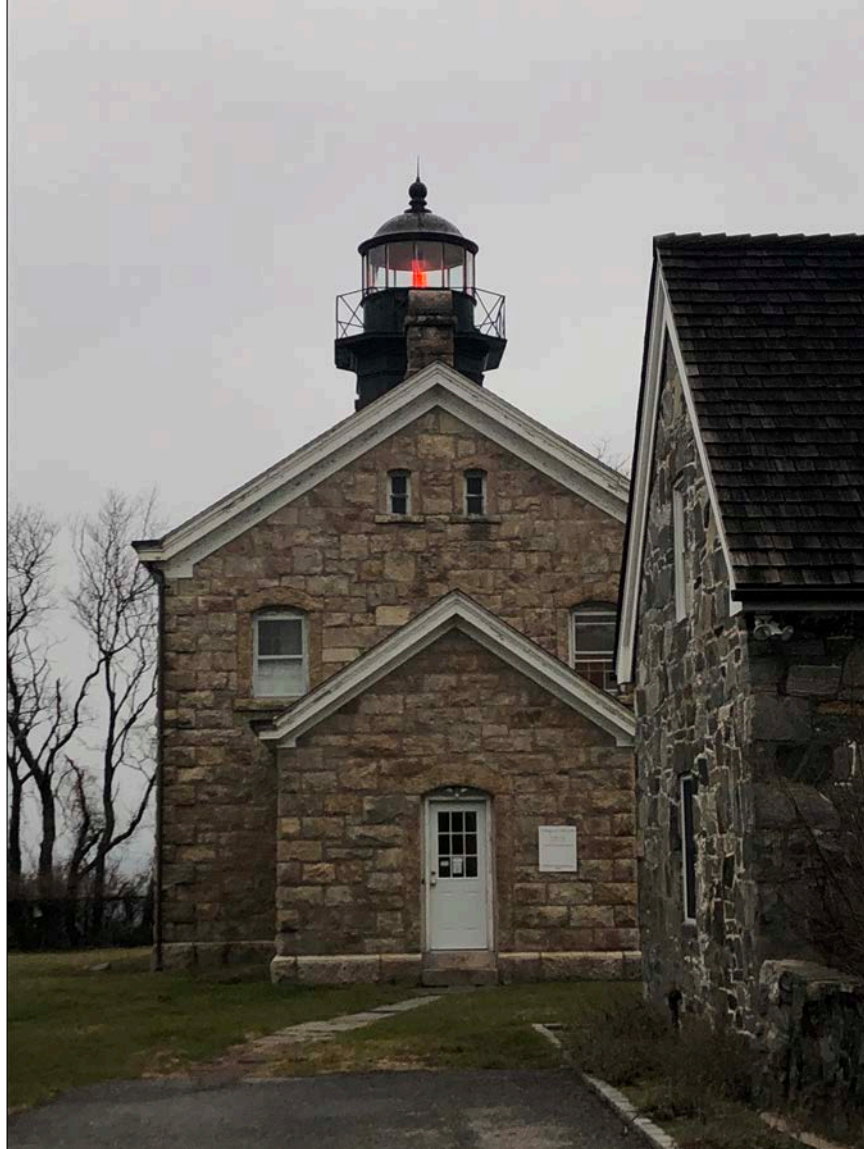
Photo 23. Corresponding to established regulatory protocols, the new LED lamp has a visual characteristic of alternating red....

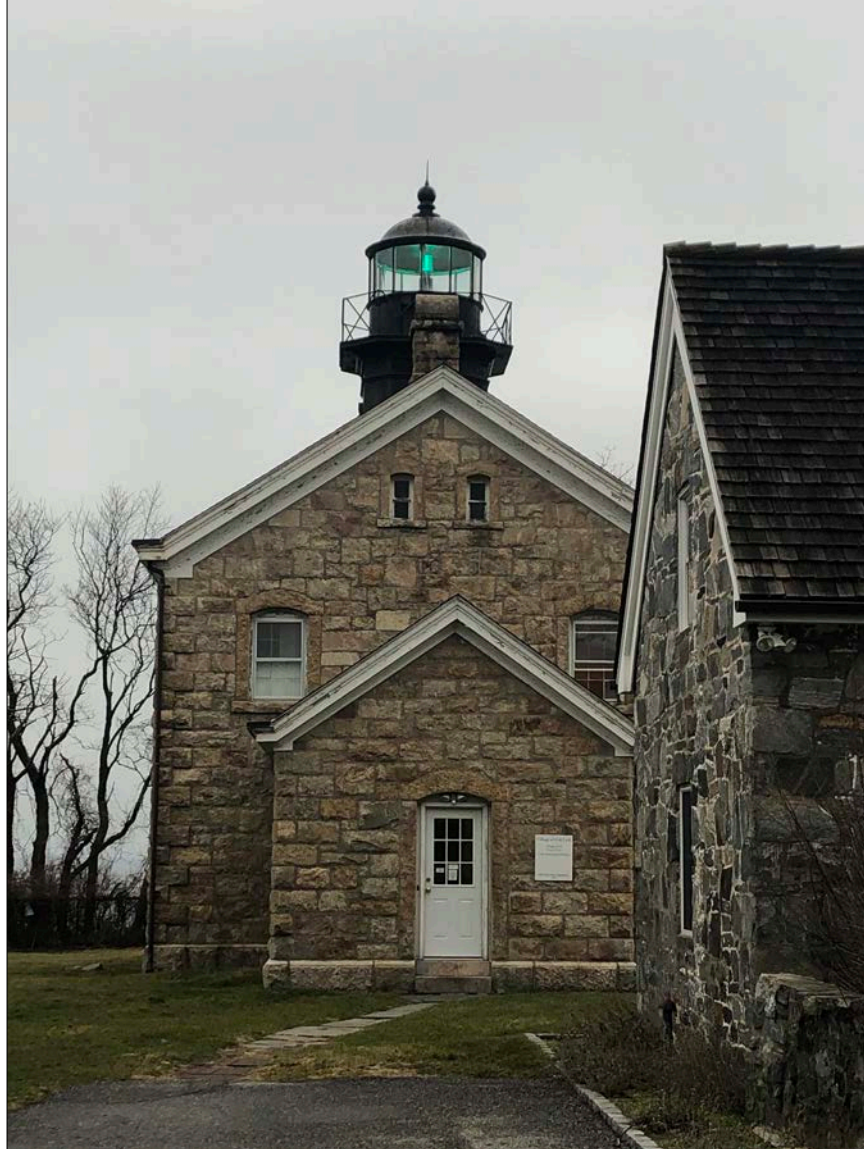
Photo 24. ... and green.

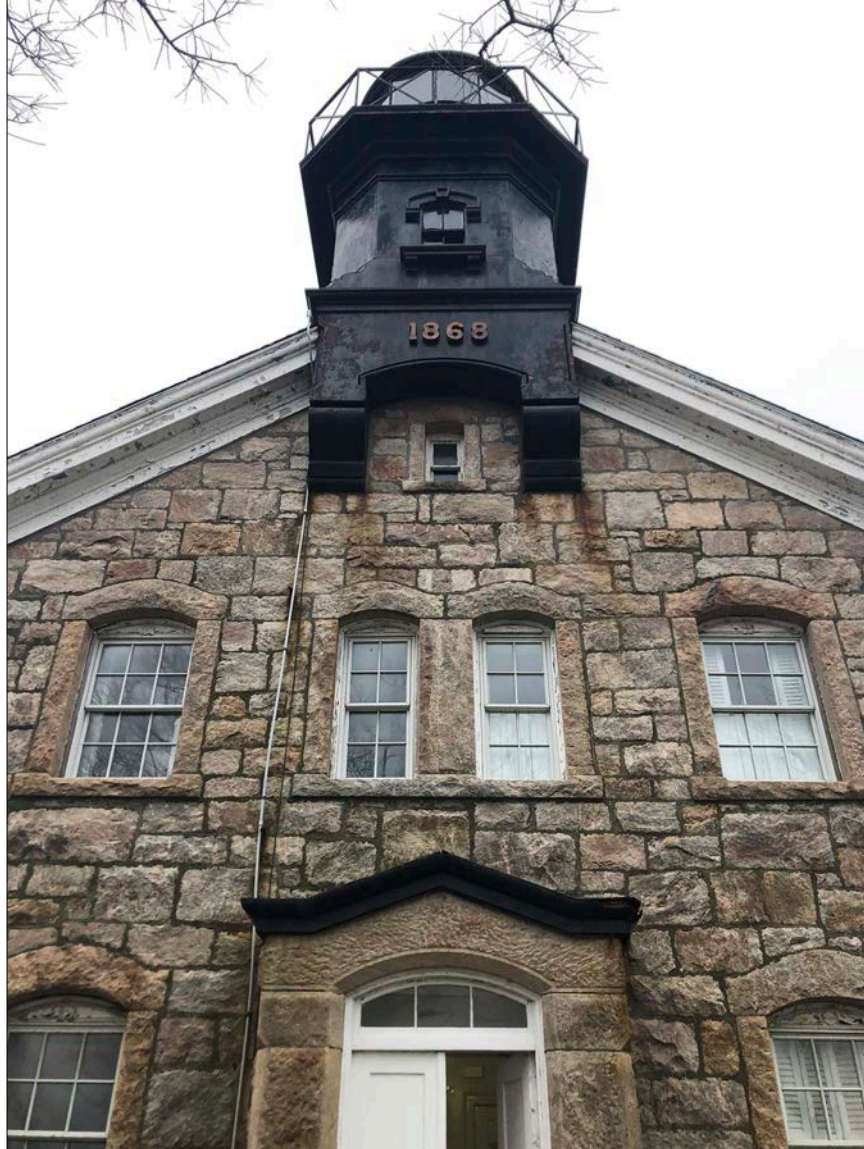
Photo 25. Magnificently classic in form, the durability of Old Field Point Lighthouse – and its 5 sisters – is truly awe-inspiring. Granite, windows, roof form and the cast iron Lantern remain in exceptional condition, with flaws that are well understood and restorable. Frontal view of dated breastplate predominates a formidable facade.

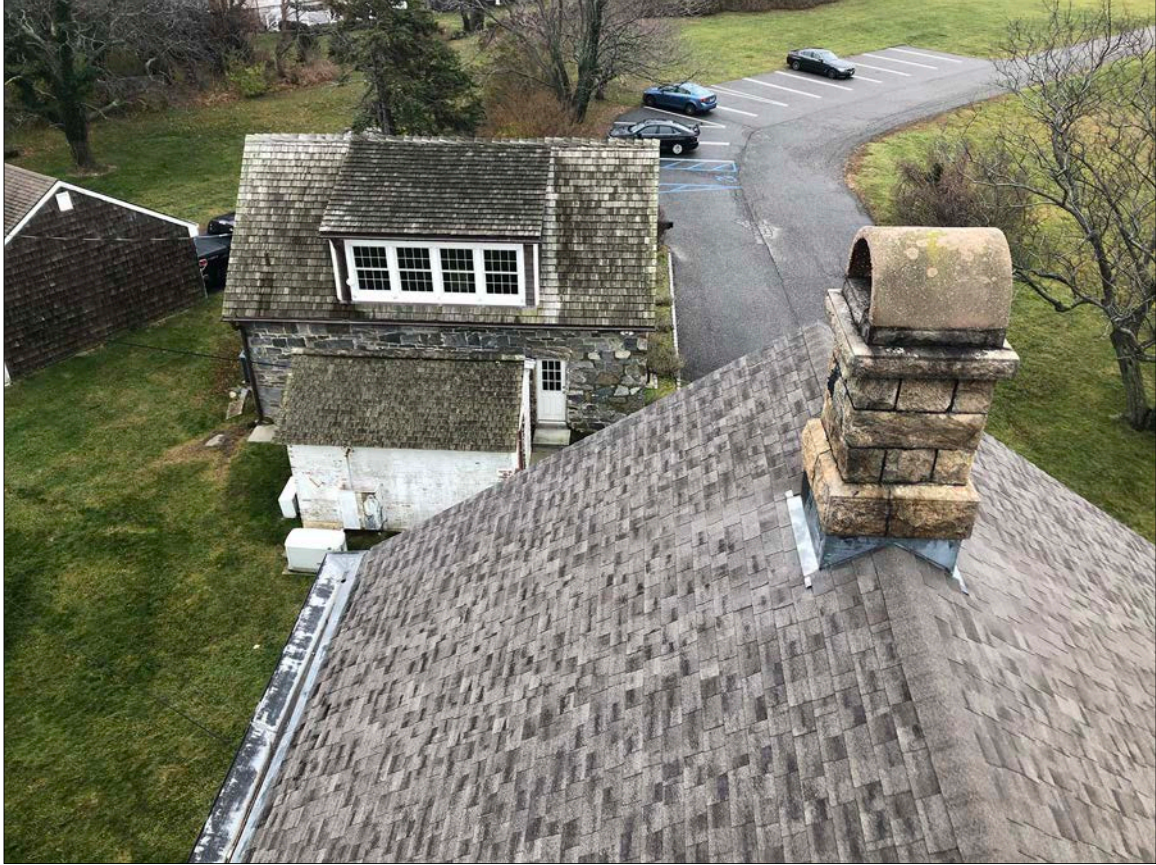
Photo 26. Composition shingle roof is nearing the end of its performance life. Chimney masonry and flashing remain in serviceable condition. Stormwater collection and distribution systems – gutters, leaders (downspouts) and subsurface stormwater conveyance components – are undersized, not well integrated, and clearly breached in numerous critical locations. The condition of subsurface elements is, on the whole, a complete mystery; further investigation, via a drain scope, is warranted.

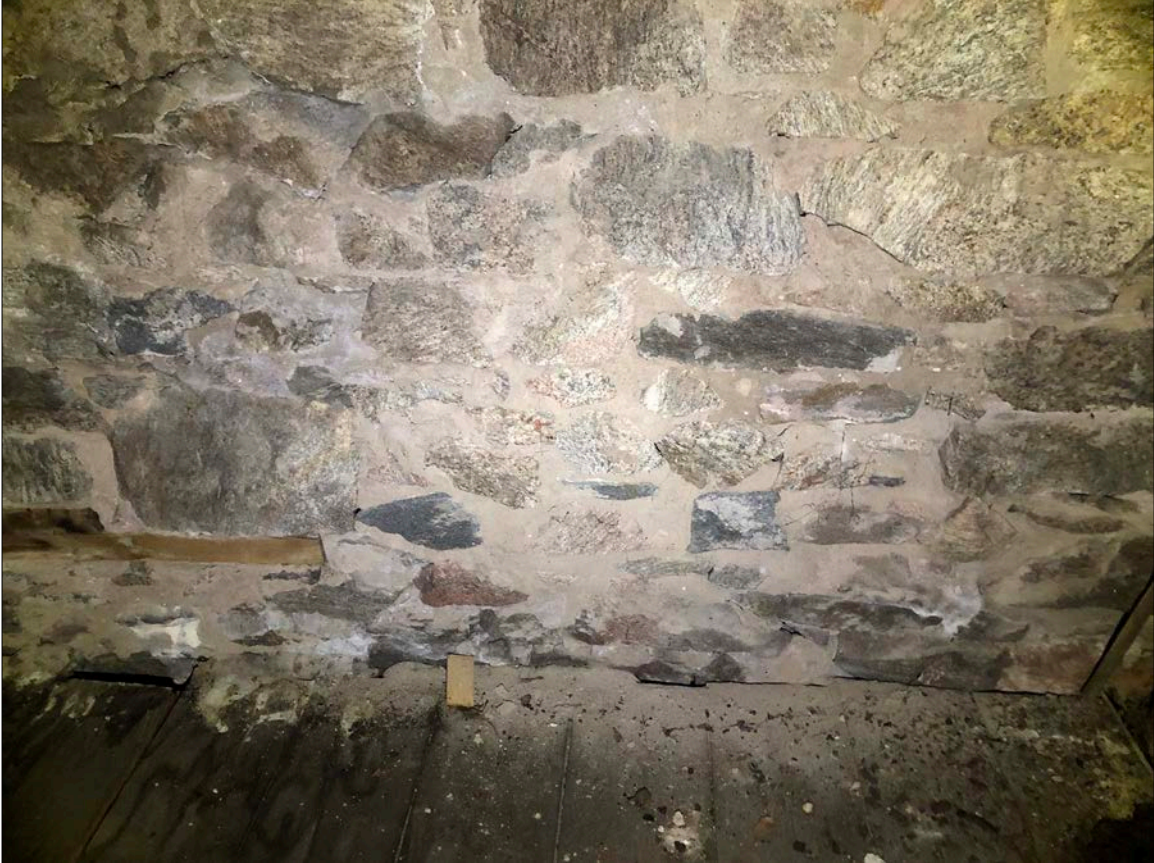
Photo 27. Upper wall system seen from the attic in the vicinity of the roof eave, where leaking gutters have led to water migration through the stone. Dusting on the adjacent attic flooring is indicative of microscopic degradation of mortar matrix. While not of particular concern, it is worth monitoring.

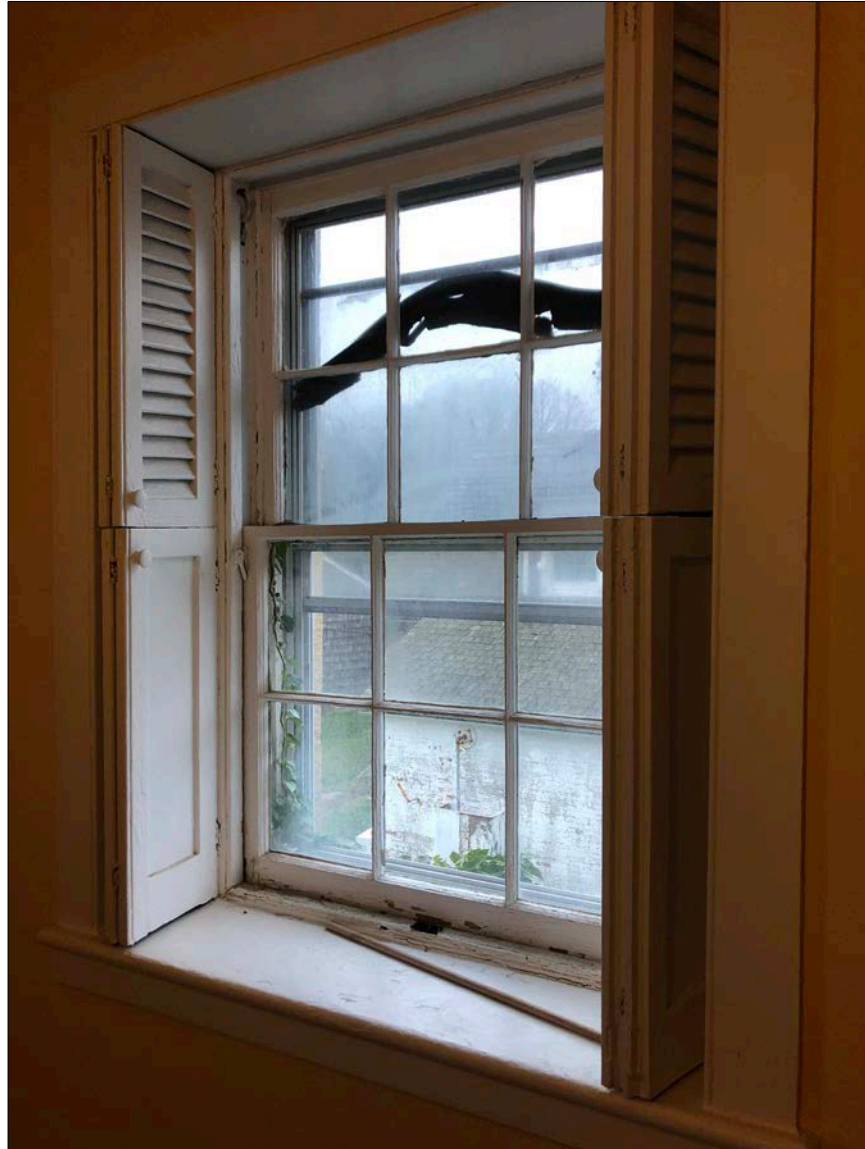
Photo 28. Early double-hung wood windows are in remarkably excellent condition, despite being somewhat sealed in by exterior triple-track storm windows. Note failing (dislodged) dry seals within the interstitial spaces, as well as encroaching vegetation and a stuck-in-place outer sash. There are far more effective ways to treat the windows and ensure superior energy, ventilation and visual performance. The integral blind shutters are beautiful.

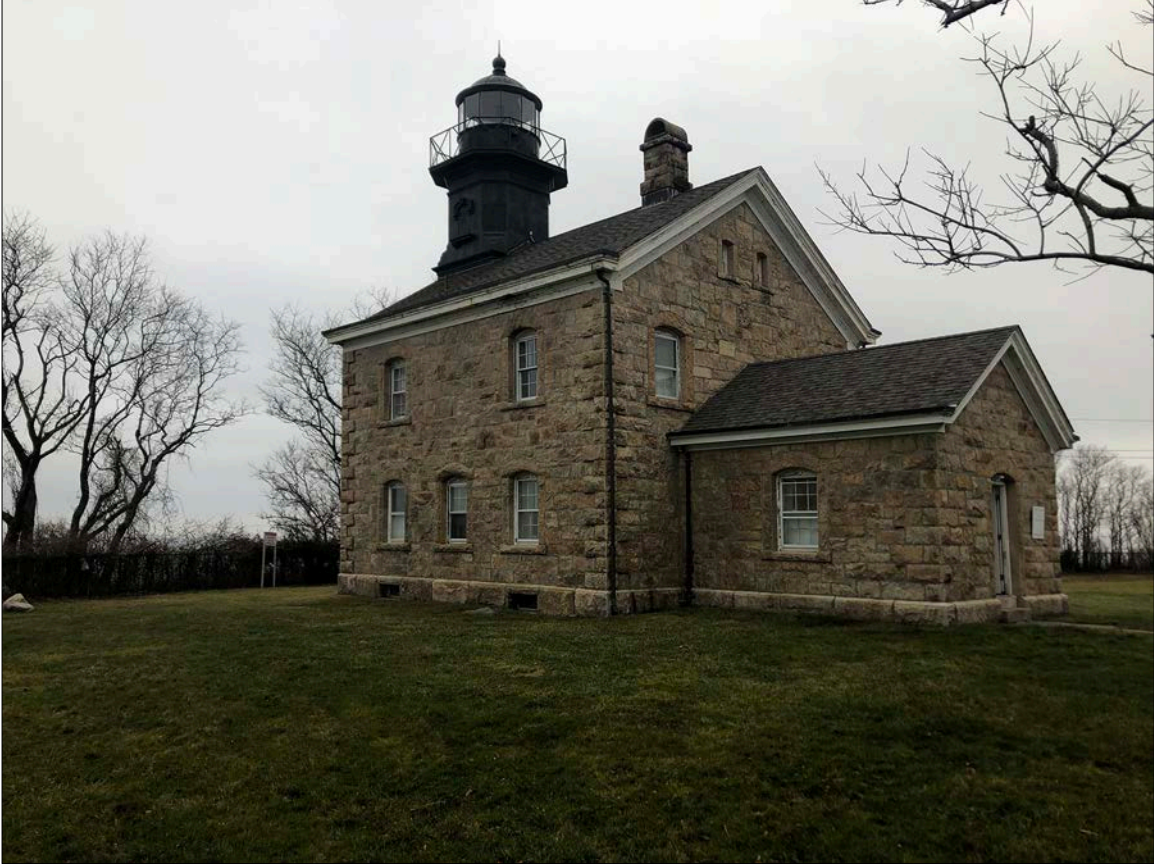
Photo 29. Quintessential view of Old Field Point Lighthouse, looking northeast. The building envelope, constructed principally of granite ashlar blocks, cast iron and simple gable roof forms is sound, though issues persist relating to stormwater management and – on the interior – structural framing.

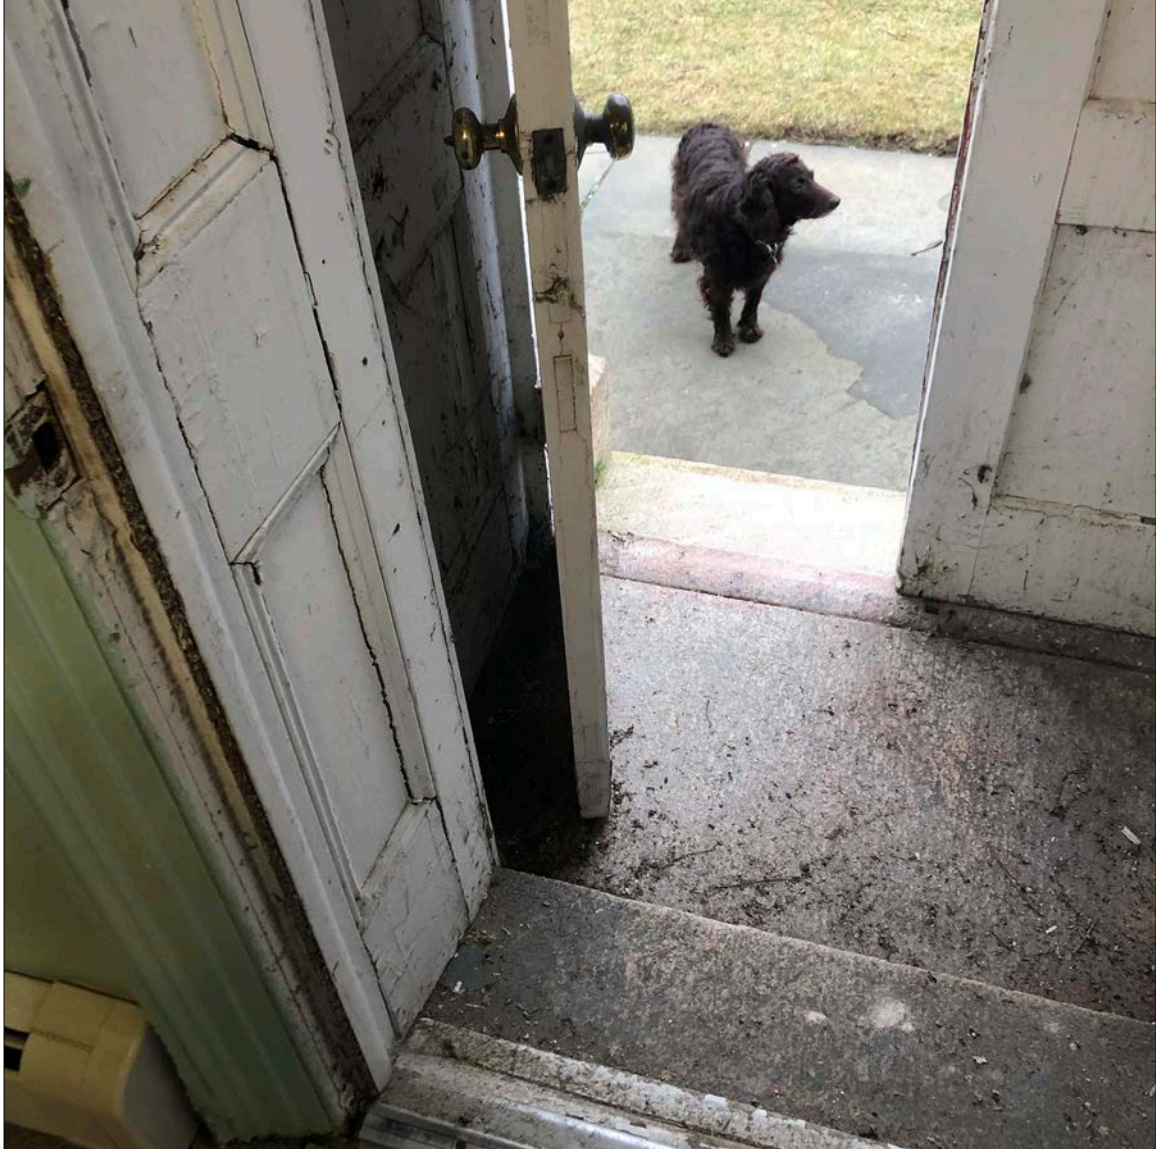
Photo 30. The formal entrance to the Lighthouse is through the tower (north) double-leaf door. The entire assemblage of floors, walls, doors, hardware, lighting is in remarkably authentic condition.

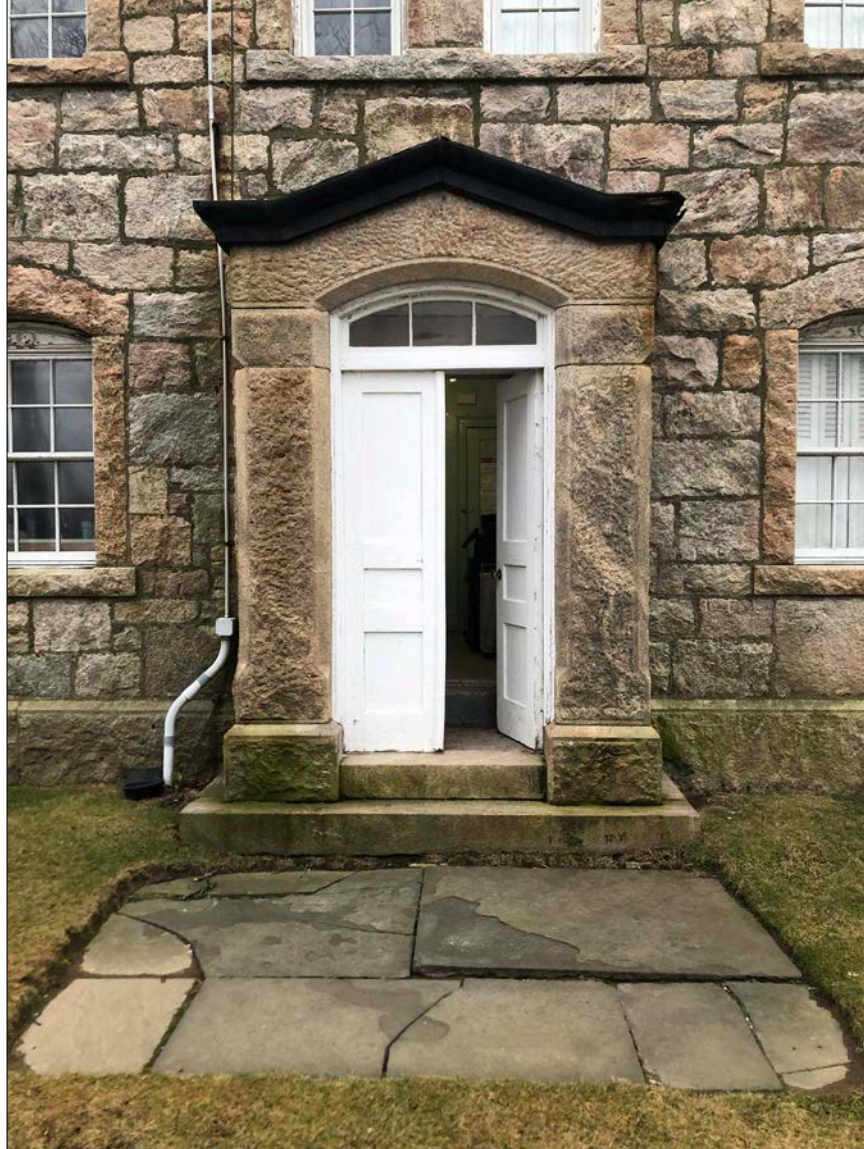
Photo 31. Tower (north) entrance and frontispiece. Aside from the errant electrical conduit to the left (east) and the cracked corner of the cast iron cornice, this entrance is in stunning condition. Bear in mind, too, that is has been the sole point of first contact for almost every major storm over the last 154 years.

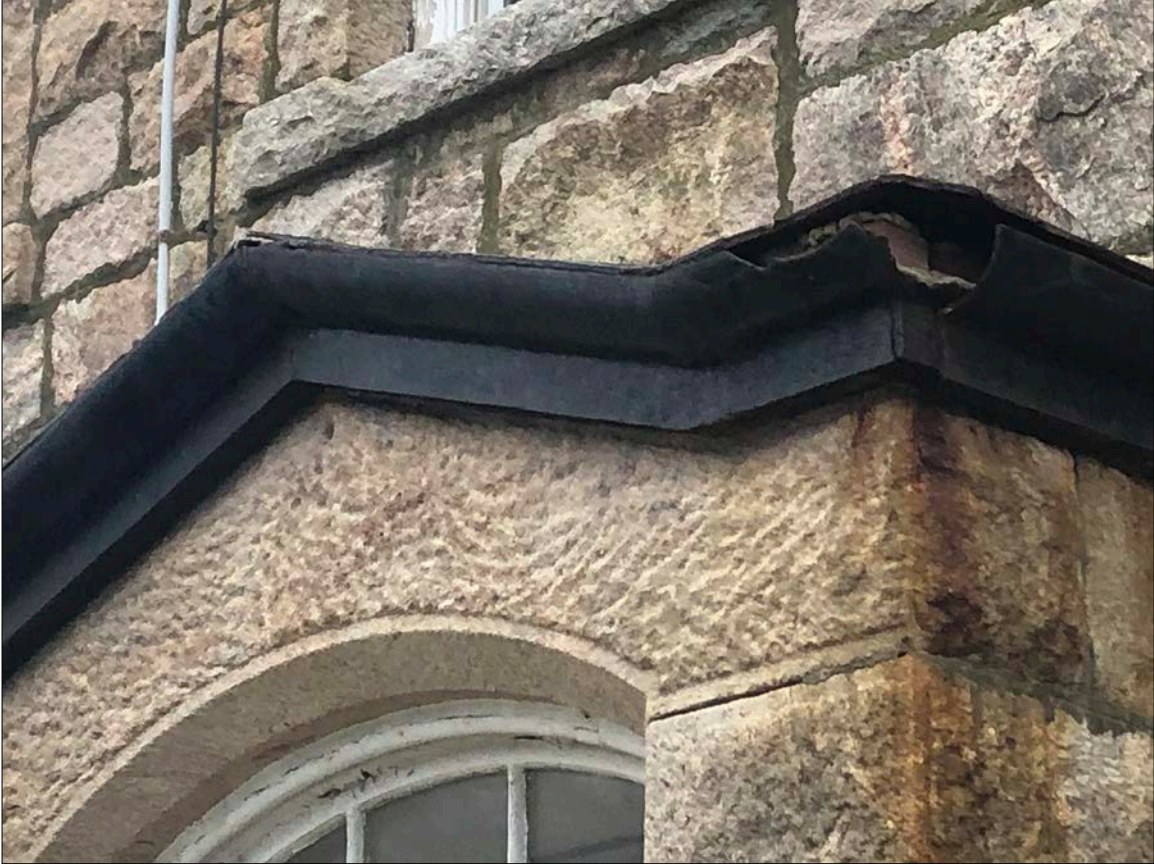
Photo 32. Detail of cracked corner of north entrance cast iron cornice. This is fully restorable, in cast iron (i.e., not alternative materials of lesser durability).

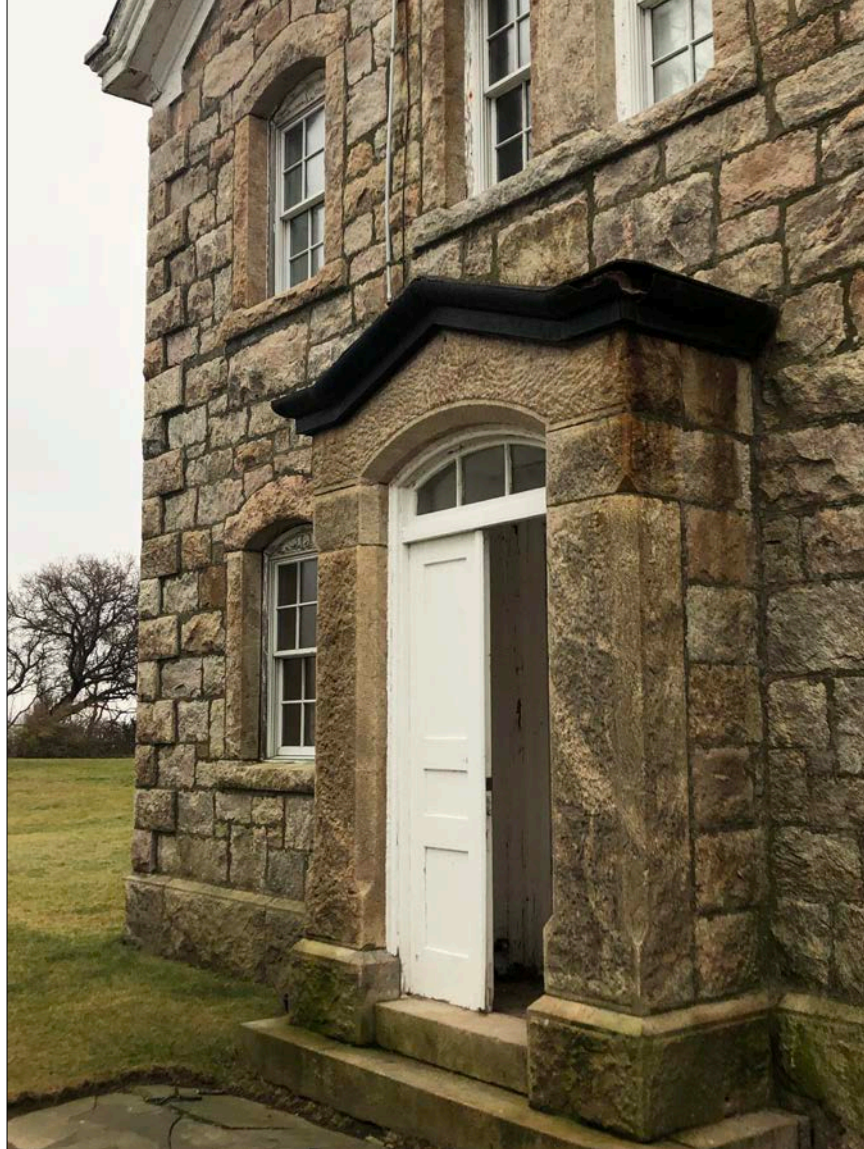
Photo 33. North facade and projecting Tower entrance, looking southeast.

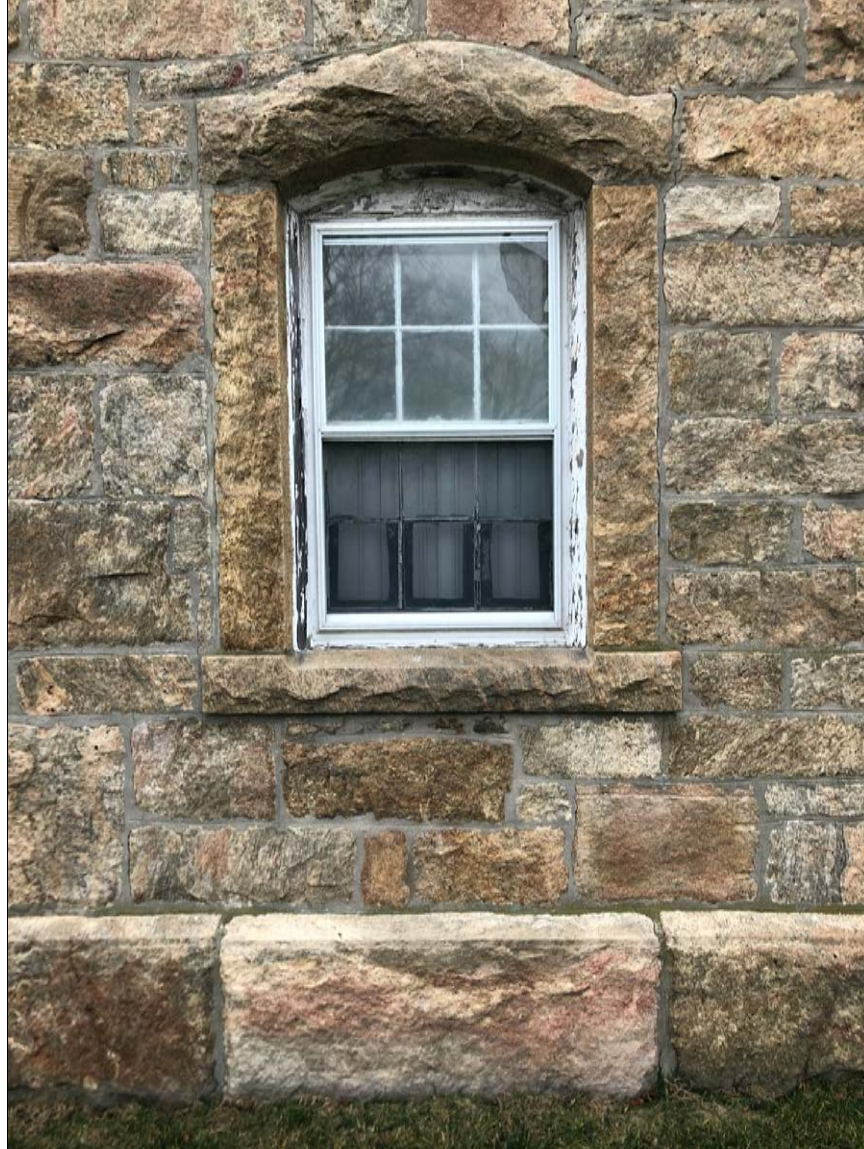
Photo 34. Early double hung wood windows, and their wood casing, are in highly serviceable condition, requiring primarily reconditioning of their wood substrate followed by a high performance primer and paint coating system. Colors are advised to be based on originals, information of which may be gathered via a comprehensive paint color and material analysis. Aluminum triple track storm windows tend to corrupt underlying early wood windows and finishes more than they might provide any ambient benefit.

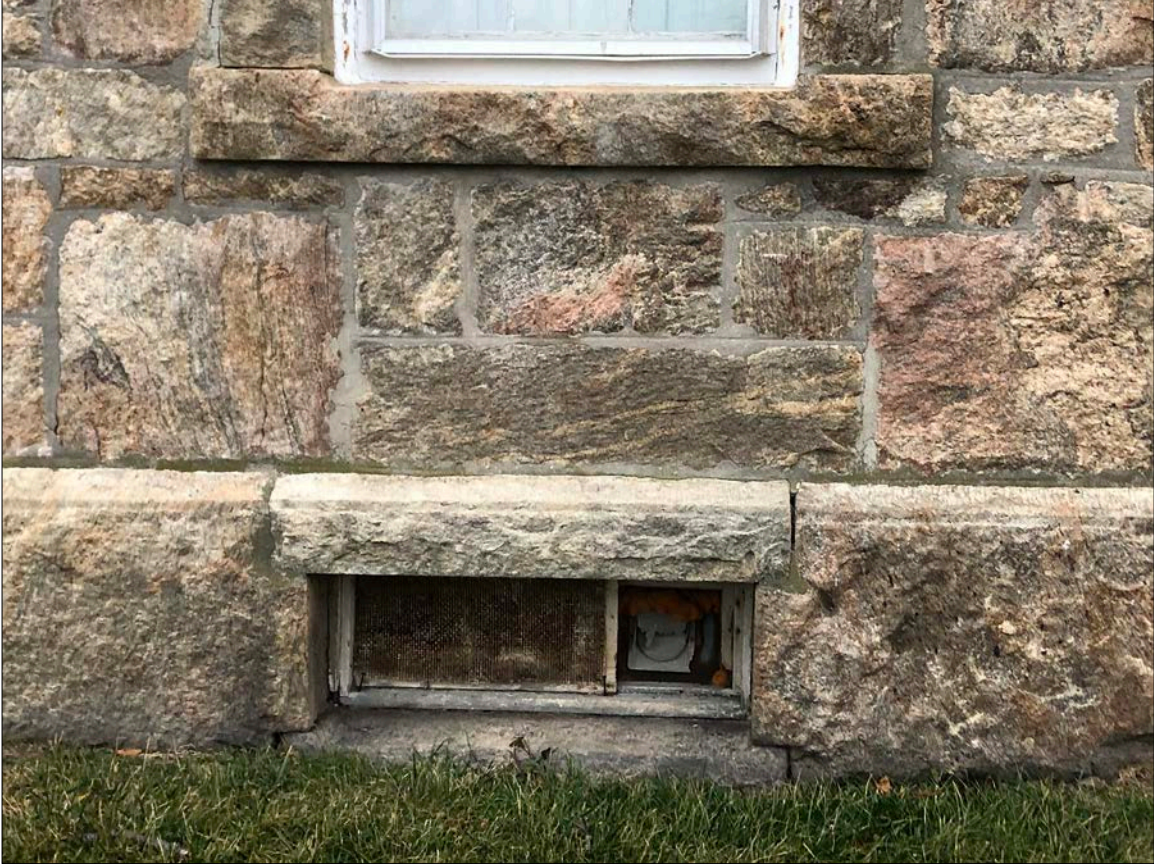
Photo 35. Original ventilator windows fitted within the foundation walls and servicing the cellar played a large role in the health and stability of the Lighthouse and its occupants: Disallowing the buildup of radon, illuminating and ventilating the cellar and – via convection – upper occupied floors, oxygenating the original lamp, and optimizing ambient moisture. Blocked, they provide no benefit and allow for the ingress of water to occur unnoticed.

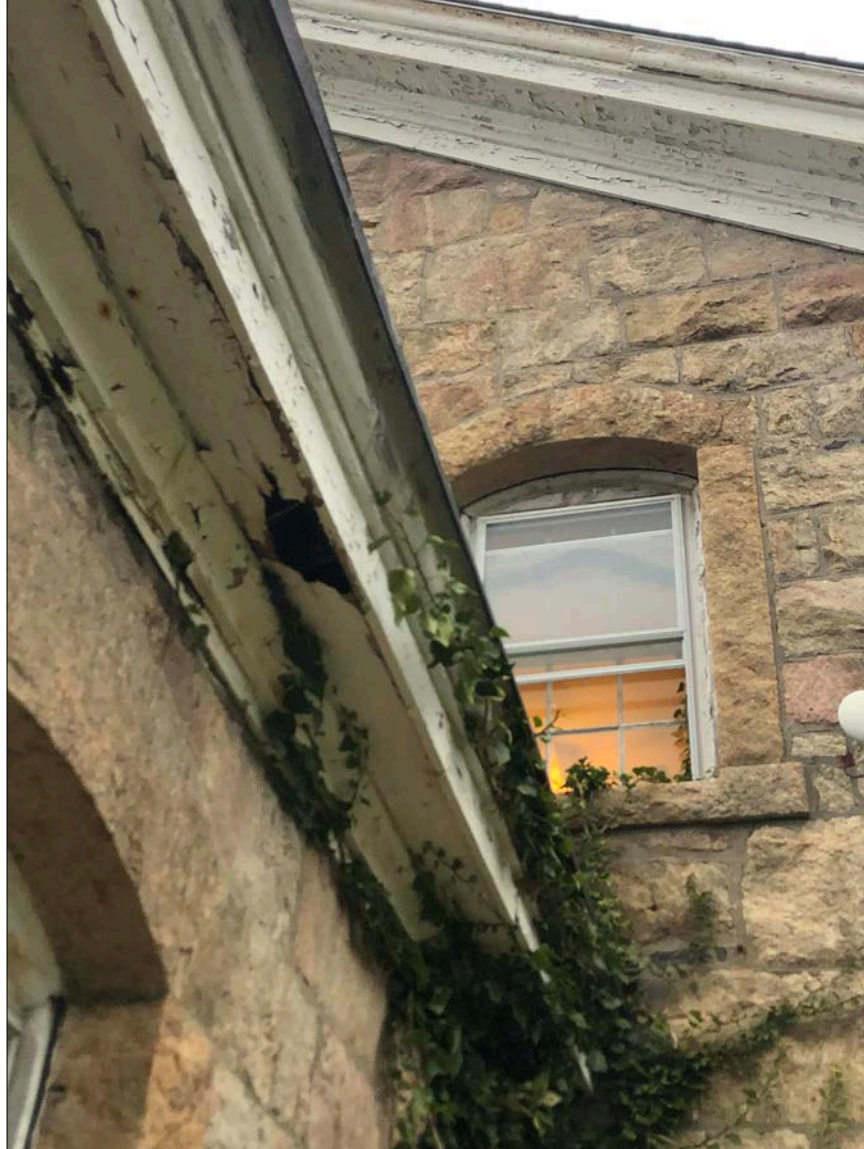
Photo 36. Breaches in the stormwater collection and distribution system have led to serious degradation of structural framing and soffits, and have fed rampant vegetative growth occurring in the building's southeast corner.

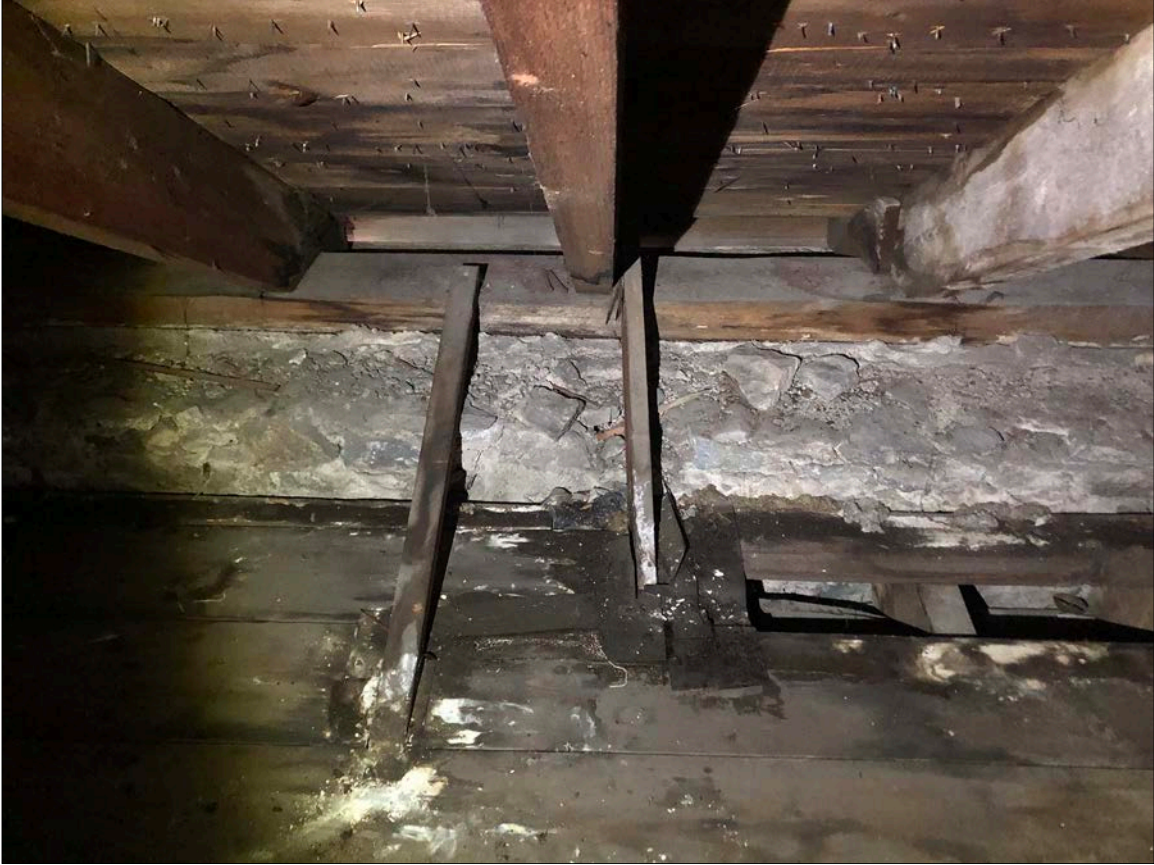
Photo 37. Ties, sister joists, and other interventions have occurred at both the roof rafter structural framing system and, illustrated below, floor plate framing. This has universally been necessitated by the inability of the roofing, flashing, gutters, downspouts and subsurface connections to properly and consistently collect and move stormwater safely away from the building. White stains on the right framing member in the image indicates water staining and residual water-borne particulates (salt).

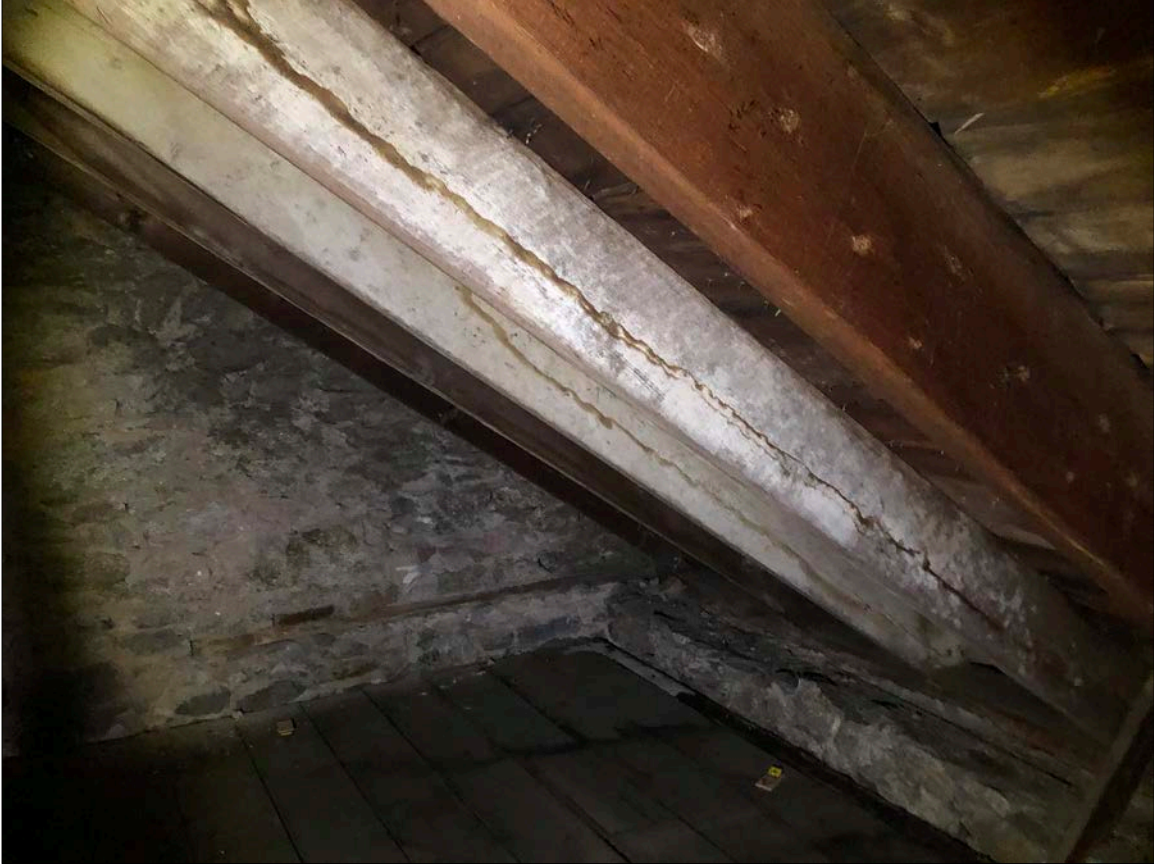
Photo 38. Another view in the attic shows the extent of prolonged water migration... and damage.

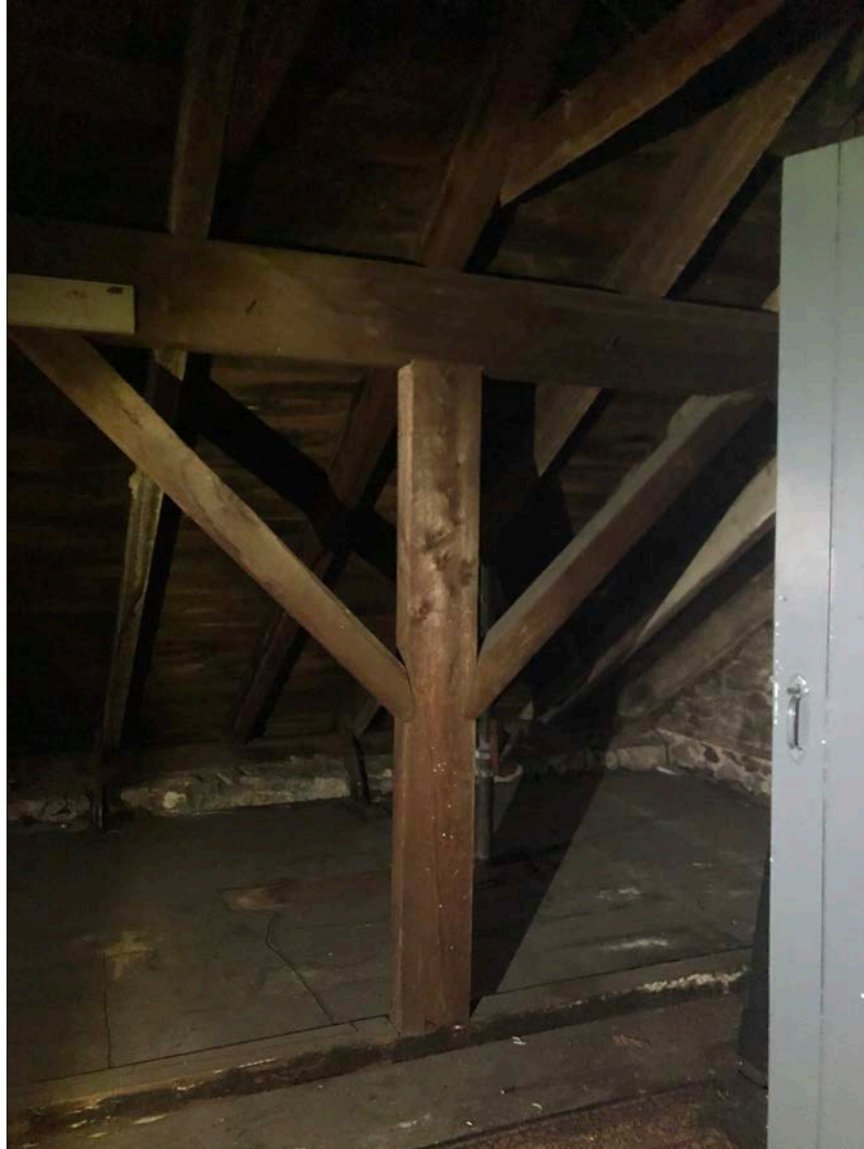
Photo 39. In contrast to the previous two images, for areas located away from the eave gutters, original framing remains robust and pristine.

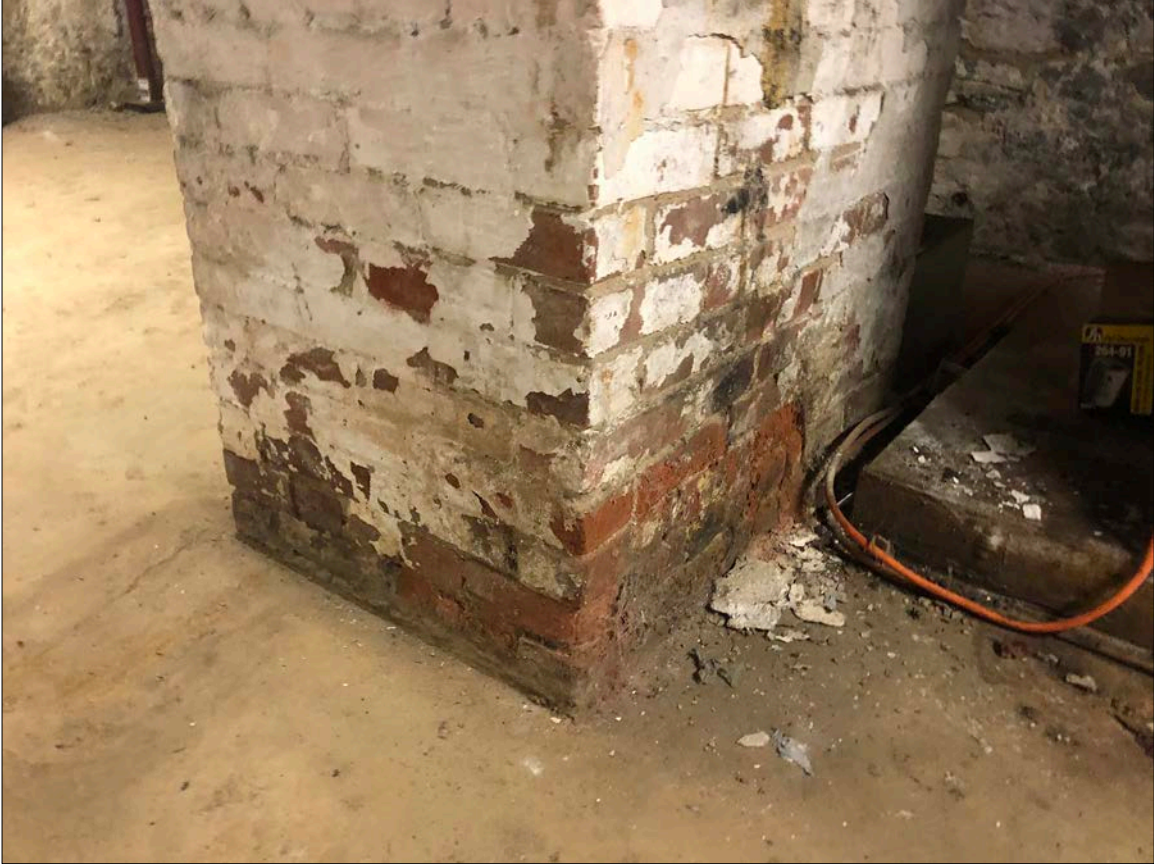
Photo 40. While common, pouring concrete floors over originally permeable cellar floors is extremely hazardous to the structural stability of porous masonry piers and foundation walls, because ambient groundwater that has always been present can no longer safely evaporate into the space (concrete is impermeable; it won't allow for moisture to transpire). Therefore moisture wicks up the only escape route available – porous brick masonry piers and foundation walls. The excess moisture and soluble salts forced into these structural systems begins a slow, measurable pace of structural deterioration. That is evidenced here by the spalling surfaces of the lower 4 courses, which will rise over time.

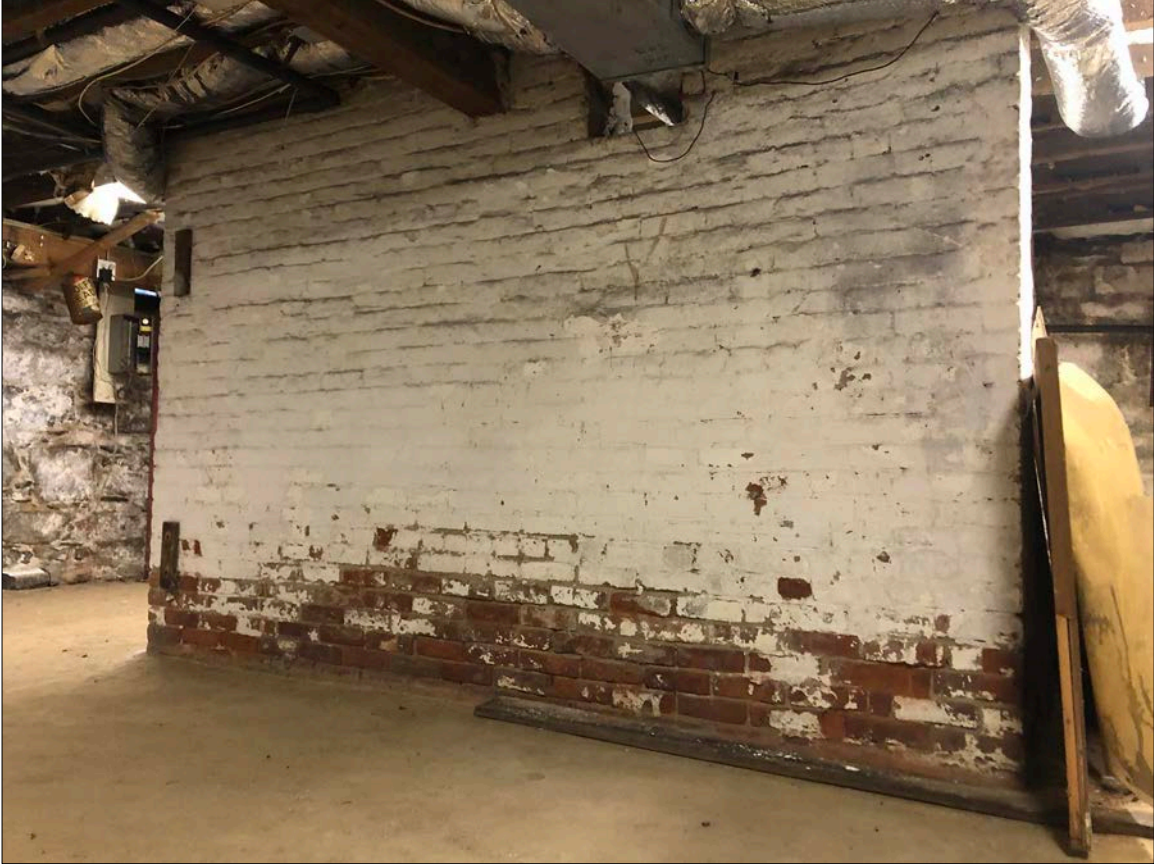
Photo 41. Like the pier, this masonry bearing wall is being undermined from beneath due to “rising damp,” the capillary action that draws moisture from the ground up into porous masonry elements, destabilizing their bases. Here there are 6 courses of brick affected. There are sound methods of arresting this condition, though not reversing it; that requires selective reconstruction.

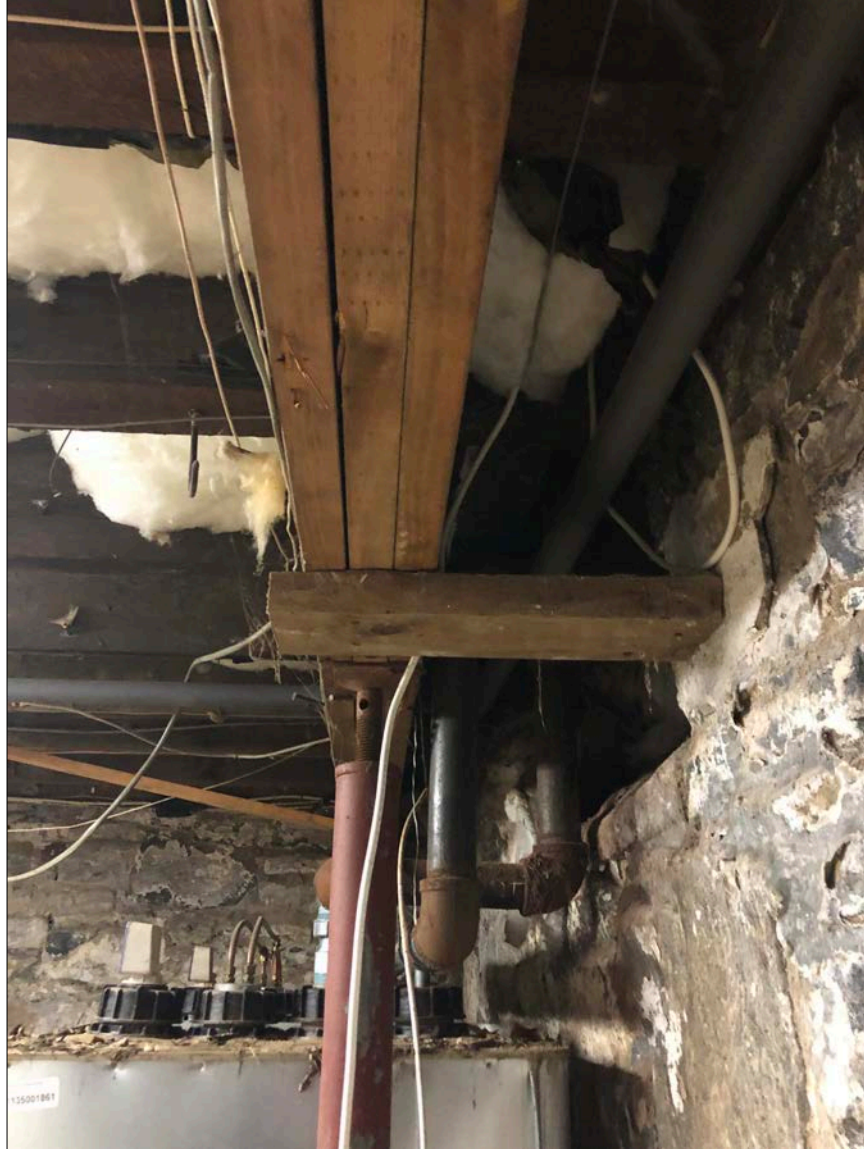
Photo 42. By far the most serious malady present in the Lighthouse is the disengagement of the entire first floor framing from its original bearing on the solid masonry foundation walls. Apparently, floor joist ends rotted from the presence of excess water caused by insufficient stormwater drainage. Rather than correcting the core issue, the rotted joist ends were cut away with their load path transferred from the walls to a series of attenuated steel columns that likely lack piers or footings. This is a potentially dangerous condition requiring immediate attention and remediation; it is highlighted as such in this Report of Investigation.

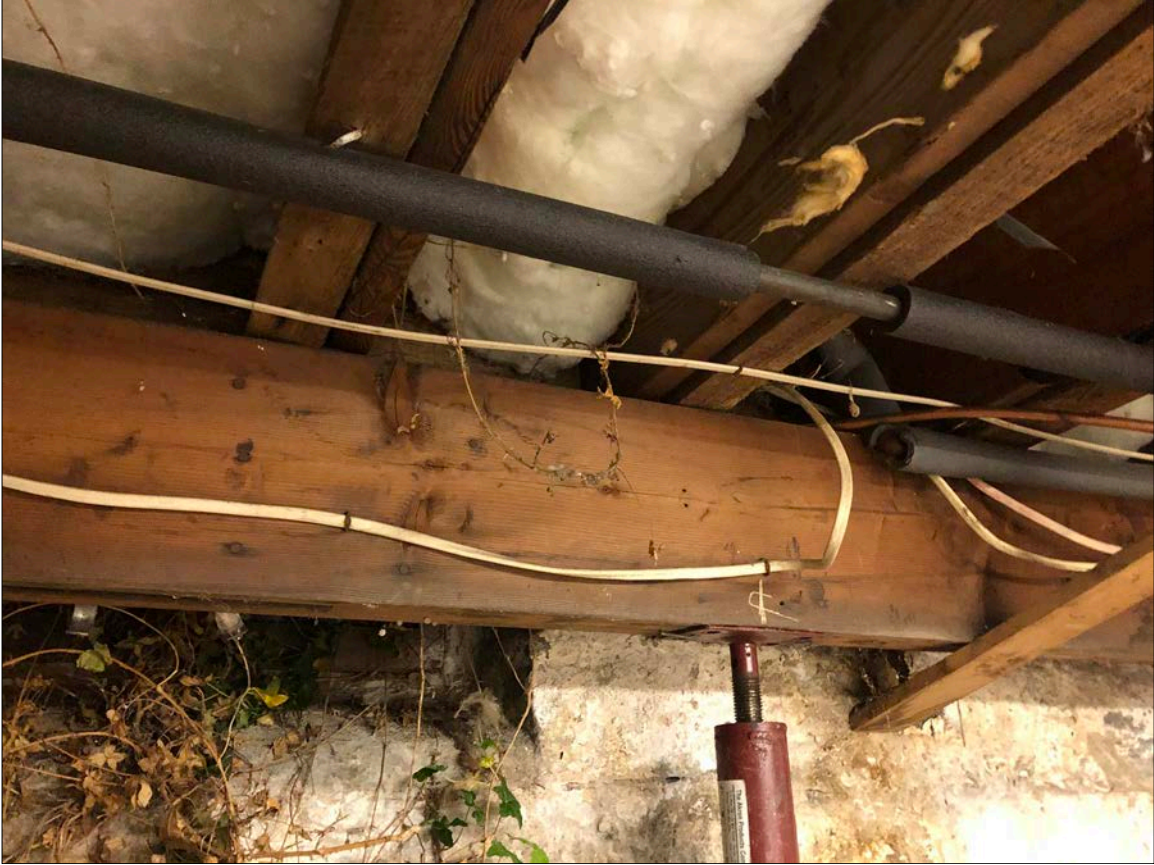
Photo 43. Many conditions of concern: 1) Disengaged floor plate; 2) Electrical wiring fastened to a girder that is inherently unstable (or, at least, structurally indeterminate); 3) Vegetation growing through the block ventilation window; 4) Blocked ventilation window(s); 5) Discontinuous insulation that is now partially trapping excess moisture within the cellar (rather than allowing it to dissipate naturally upward via convective heating, as the building's inherent design features intended); and 6) A confluence of issues so baffling that an untrained eye would find it difficult to discern where to begin... or why.
