Old Field Point Lighthouse
Setauket - East Setauket, New York
REPORT OF INVESTIGATION
22 February 2022

INTRODUCTION

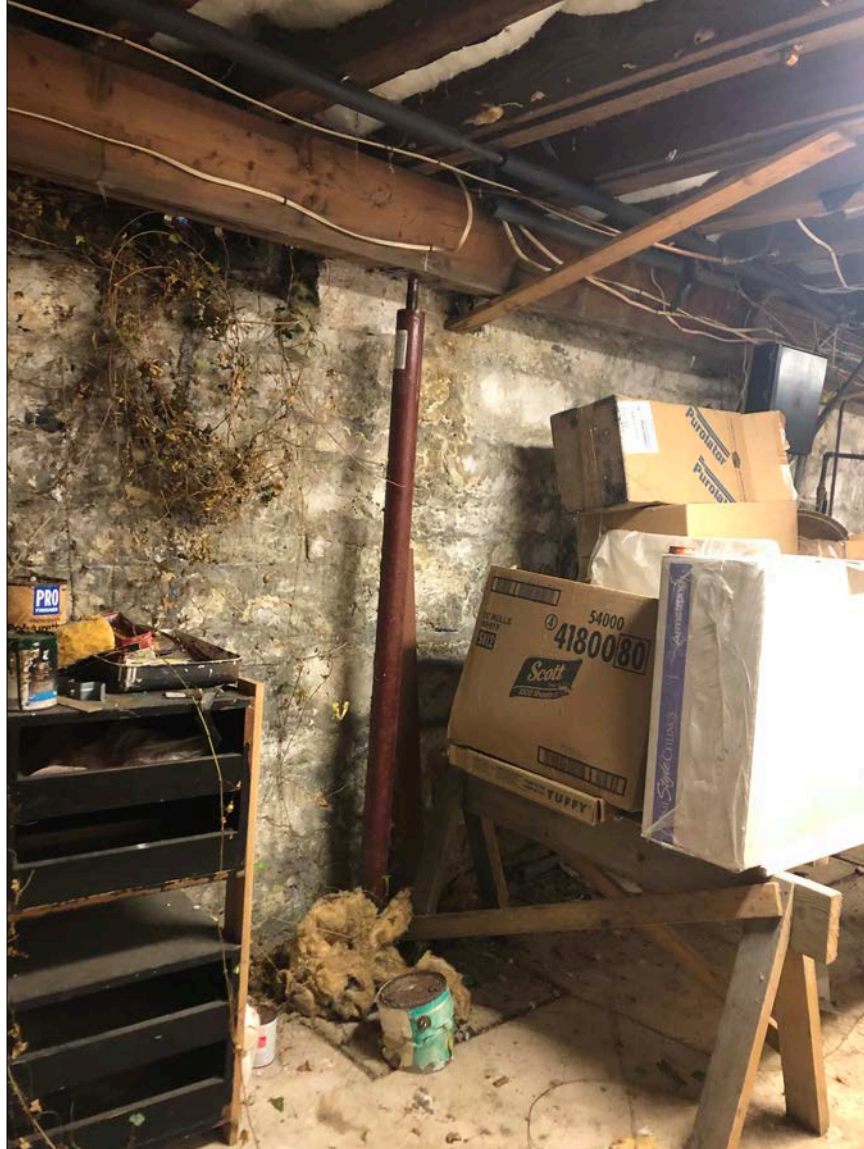
Photo 44. More of the cellar conditions described in Photo 43 above, along with accumulation of materials and debris. The square-formed concrete at the base of the column indicates that an independent pier is likely, which is positive, though the specifics of its design and installation are yet unknown.

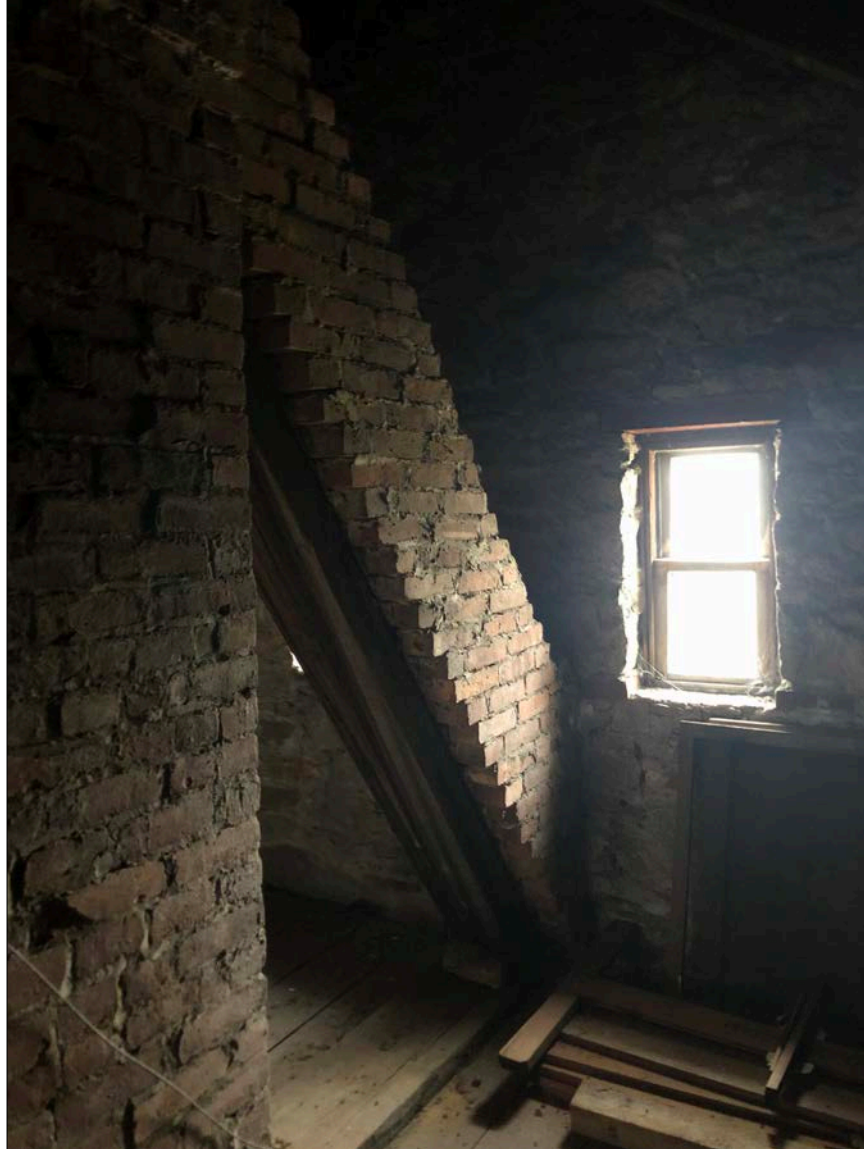
Photo 45. A corbelled flying buttress providing lateral support of the original brick chimney is engaged and in stable condition; this is an original element.

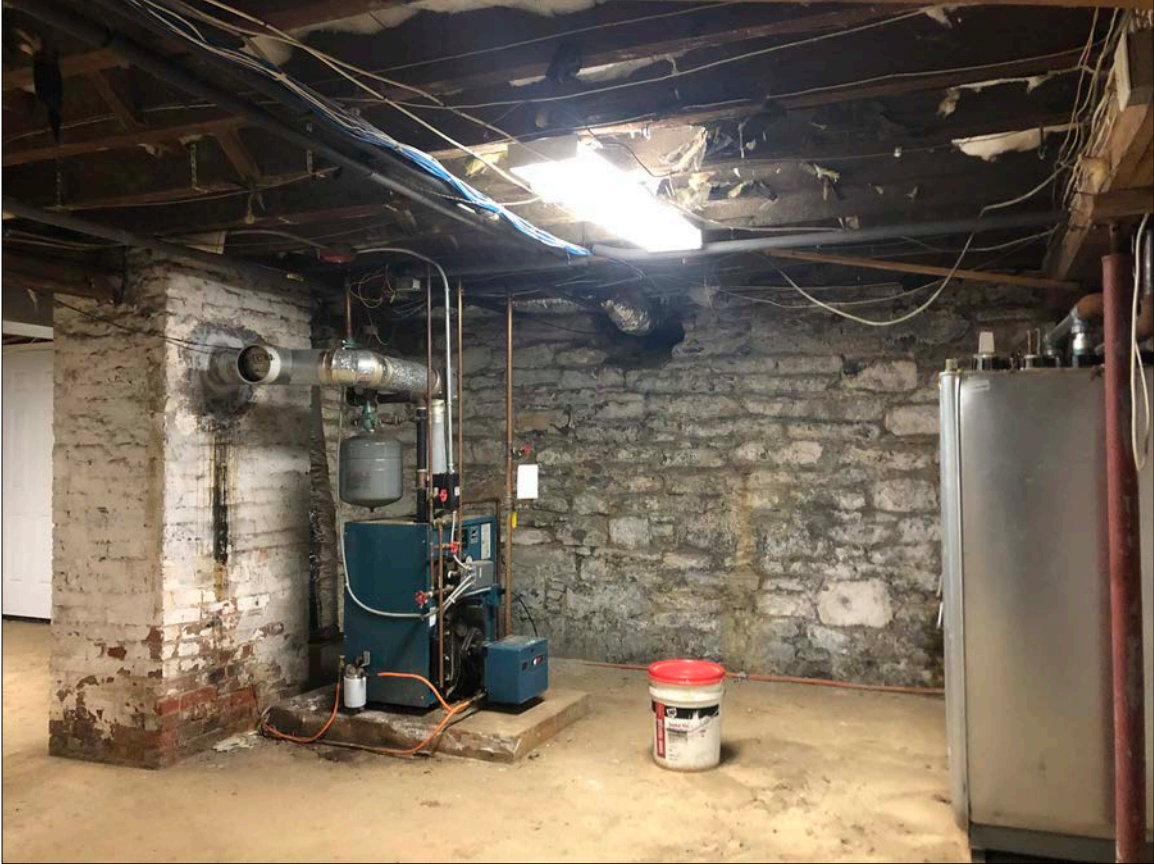
Photo 46. A relatively new boiler, skillfully piped, serves as the heart of the Lighthouse's oil-fired closed-loop hydronic heating system, which is distributed within habitable space via cast iron radiators, most original. This is an exceptionally efficient system for a building of solid masonry construction.

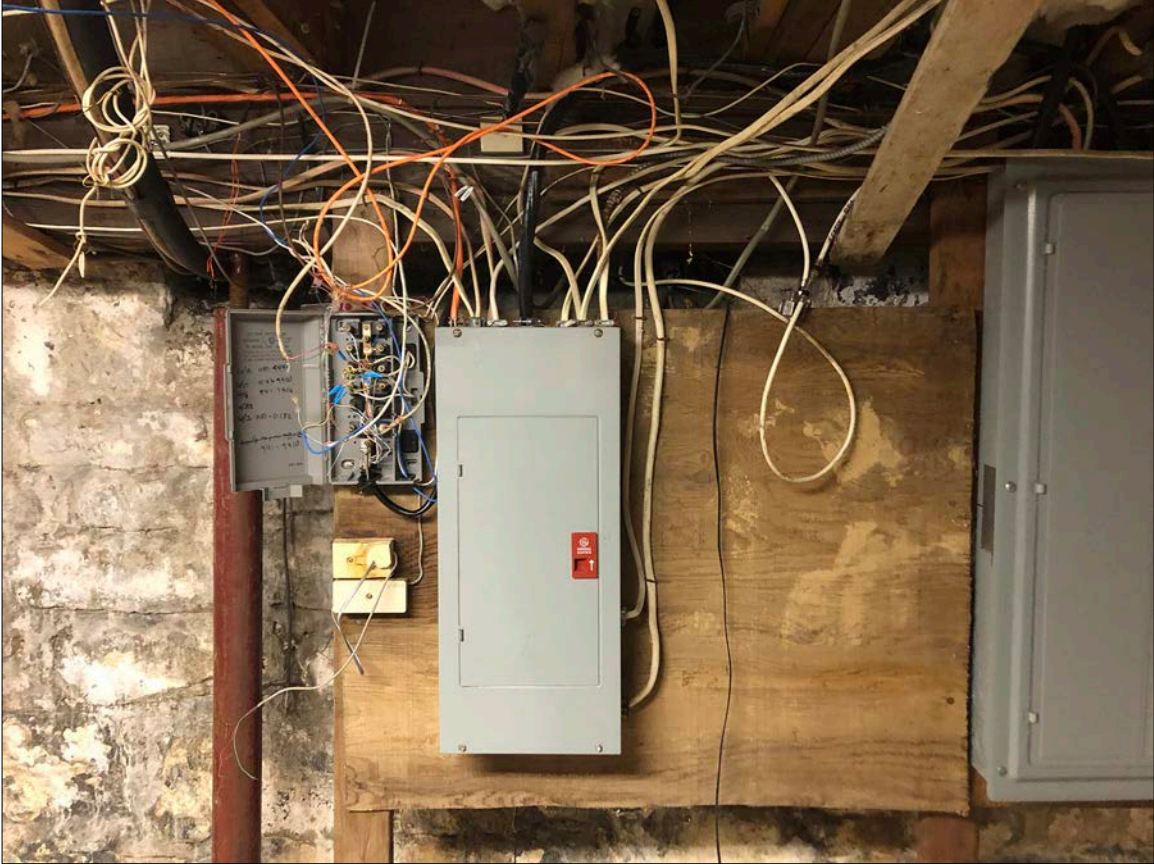
Photo 47. Electrical service is a series of *ad hoc* modifications, lacking an overarching benchmark of quality control. Beneath this panel is precisely where regular flooding forms, just inside the base of the southeast bulkhead entrance. Flooding is caused by an inadequate stormwater collection & distribution system.

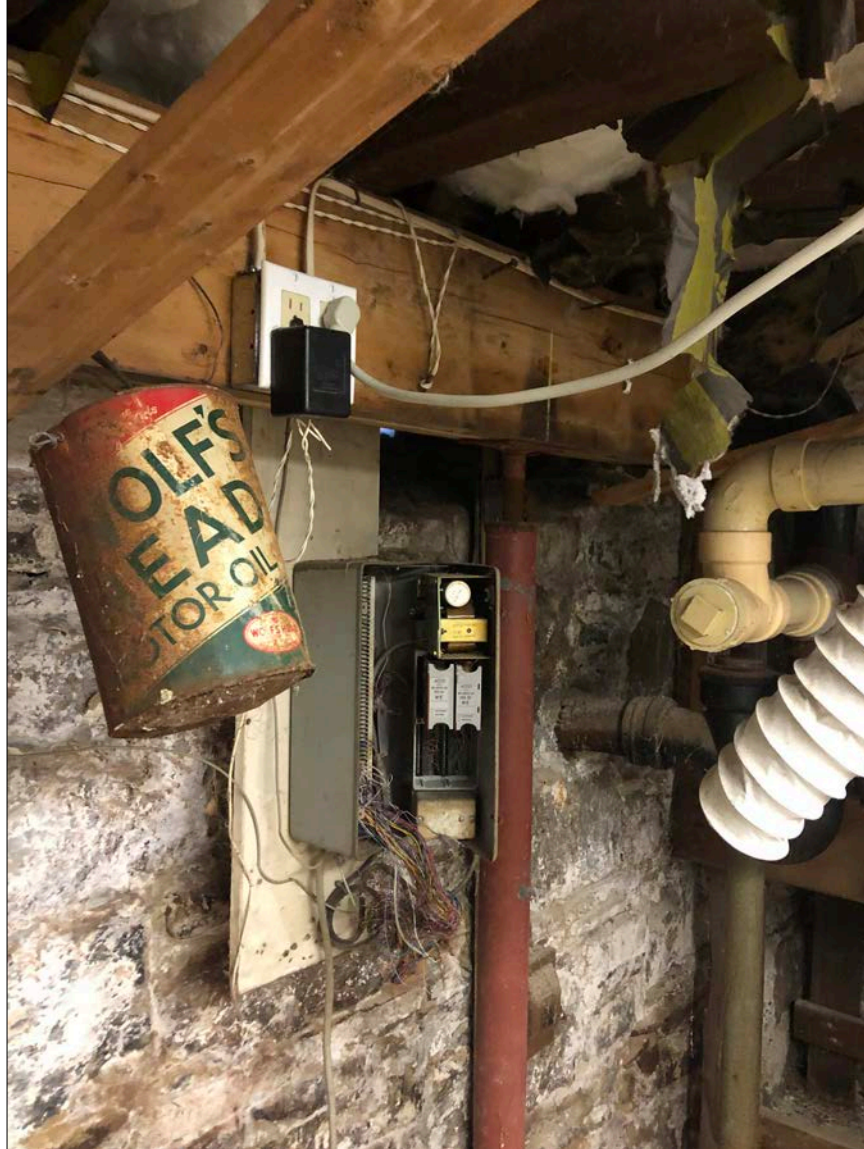
Photo 48. Myriad services and materials draped over, or attached directly to, the disengaged floor plate load transfer system.

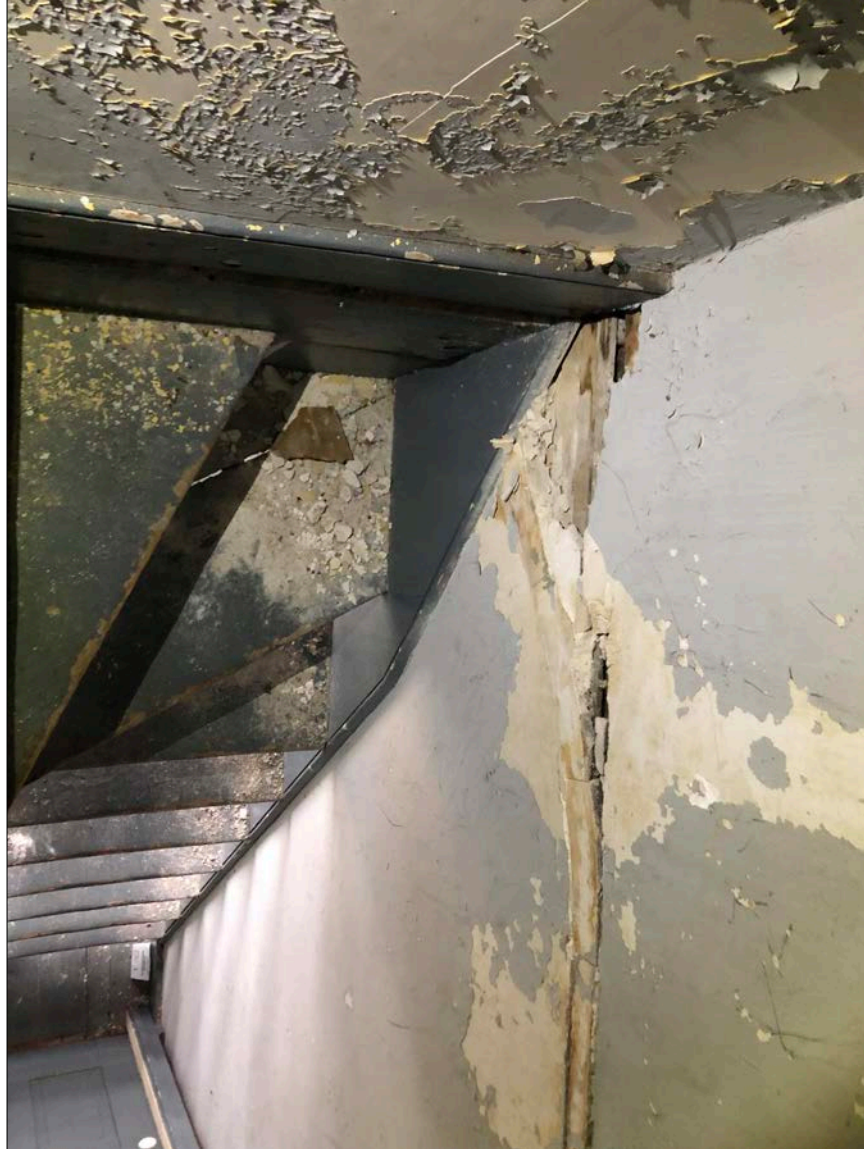
Photo 49. Generally, interior surfaces suffer from migration of stormwater – which has corrupted and deteriorated the original plaster wall finishes and other systems – and a lack of regular cleaning of those interior spaces that are only intermittently used.

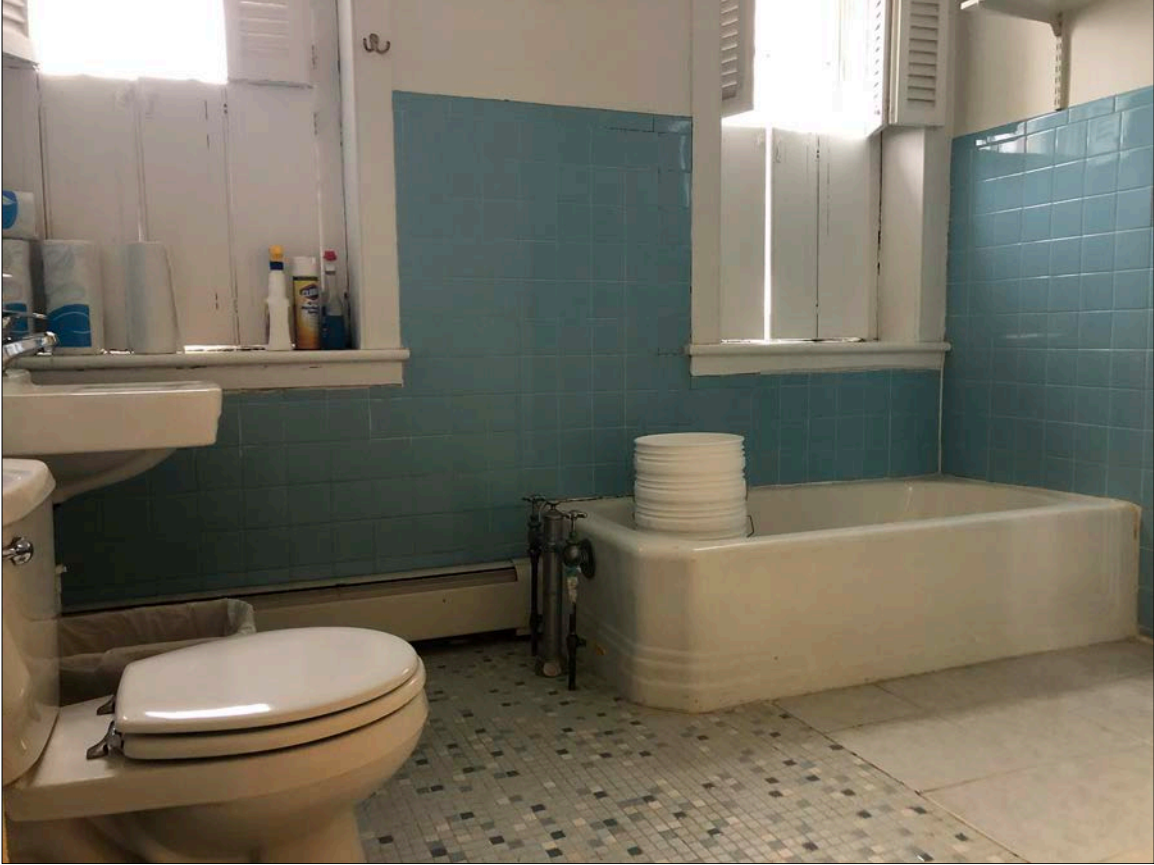
Photo 50. Arrangement of interior spaces – while beyond the defined scope of this report – are mostly original, well maintained, and suited to their purpose. Here, the early second floor bathroom indicates a level of quality in its materials and arrangement, and a level of care in its ongoing maintenance.

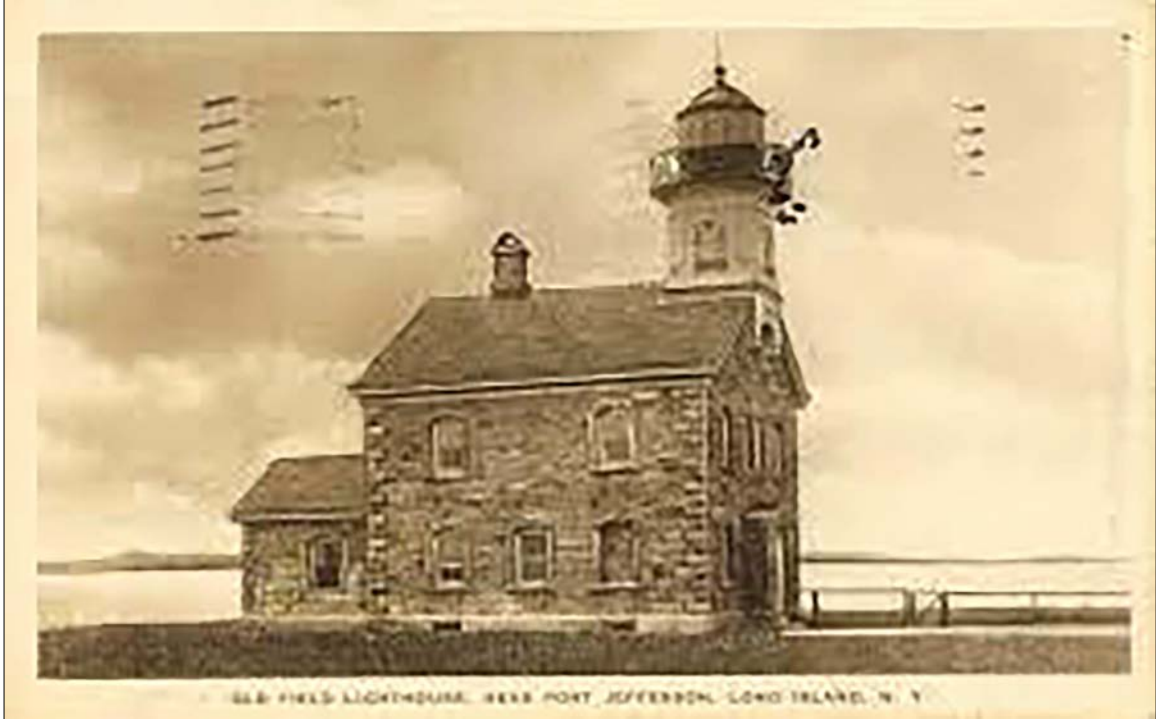
Image 1. Old Field Point Lighthouse, looking WSW, c.1868.

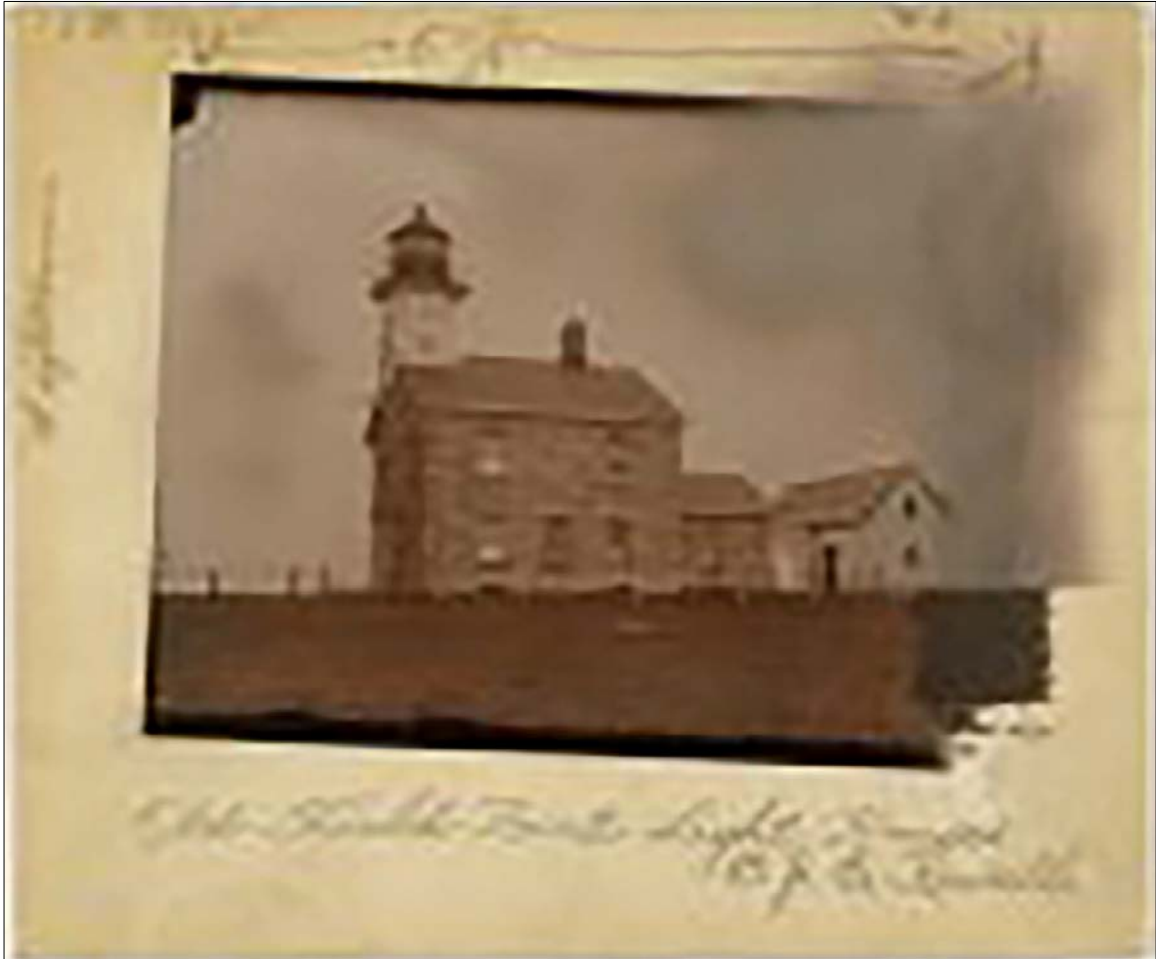
Image 2. Old Field Point Lighthouse, looking ESE, c.1875.

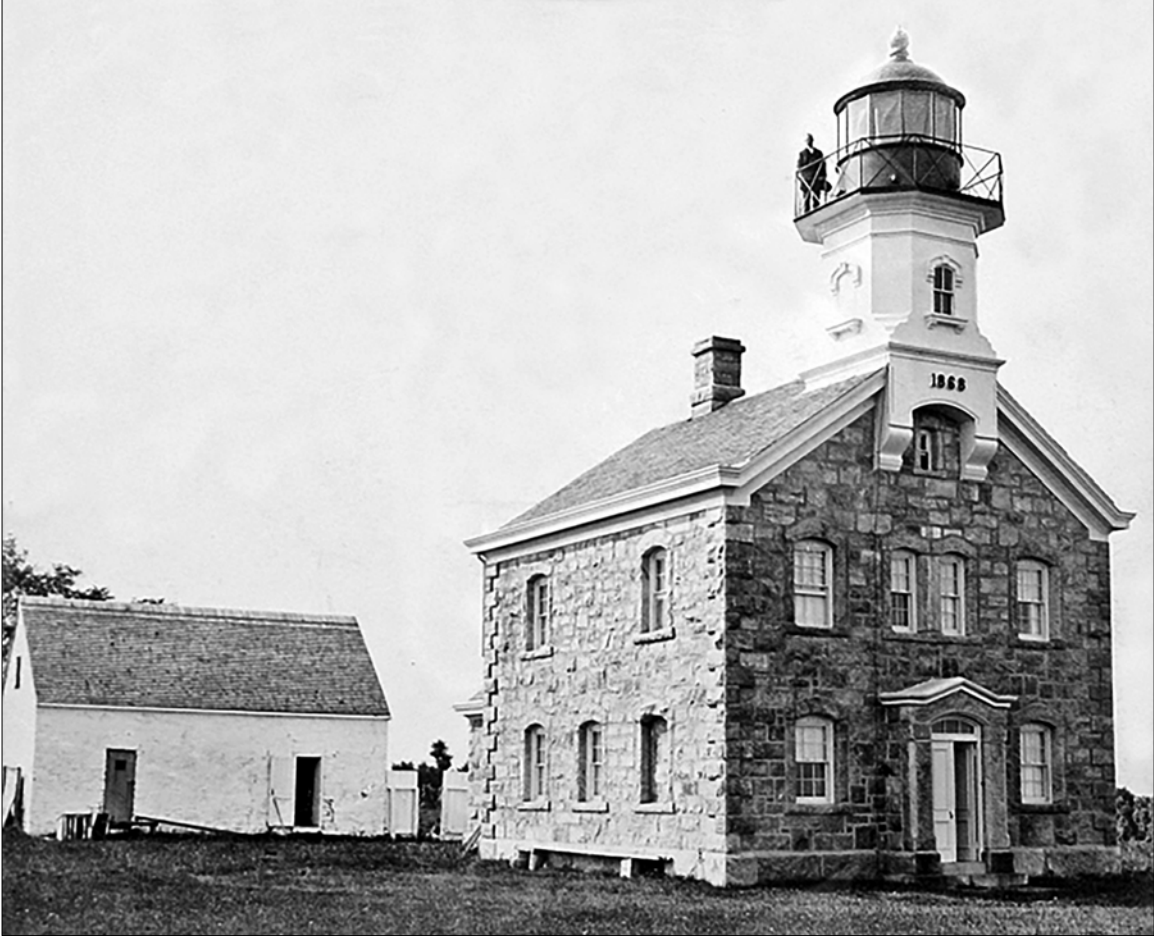
Image 3. Old Field Point Lighthouse, looking SW, c.1885.

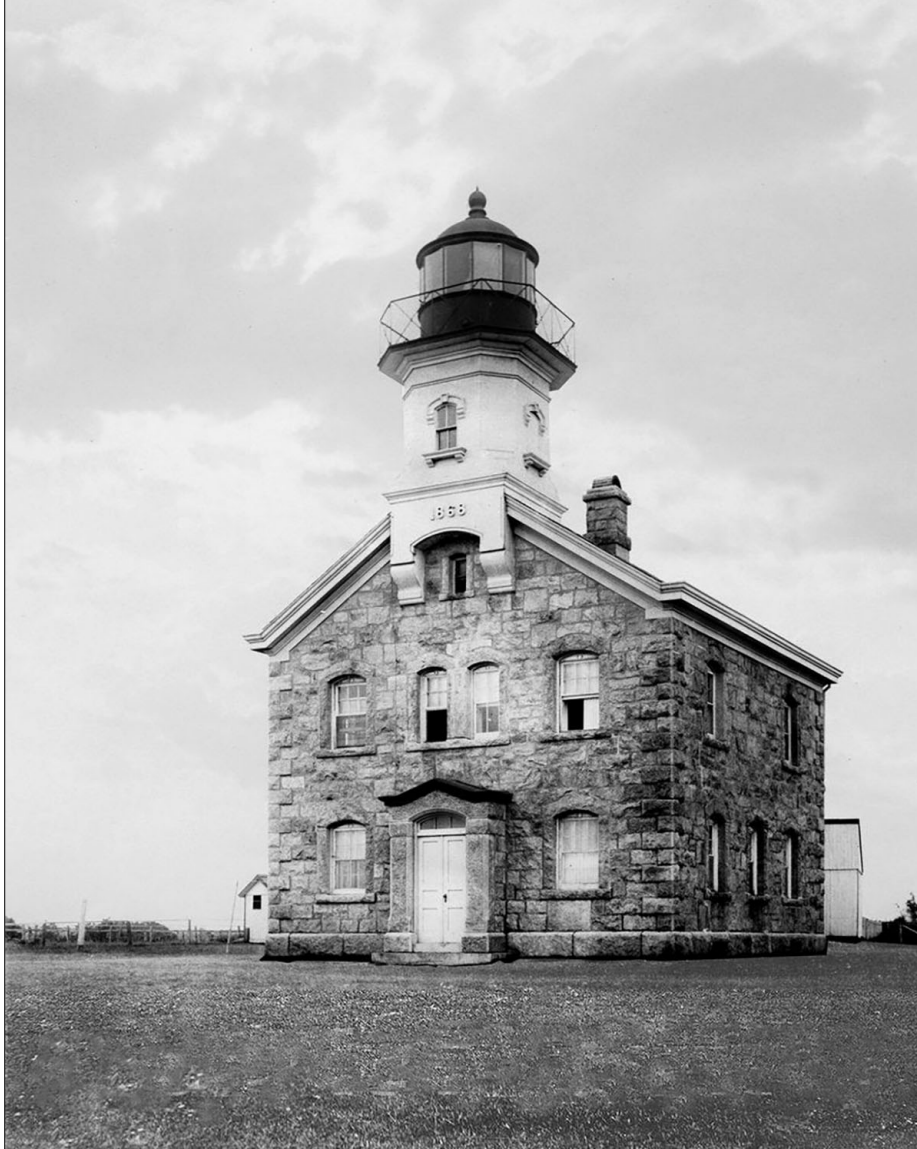
Image 4. Old Field Point Lighthouse, looking SE, c.1890.

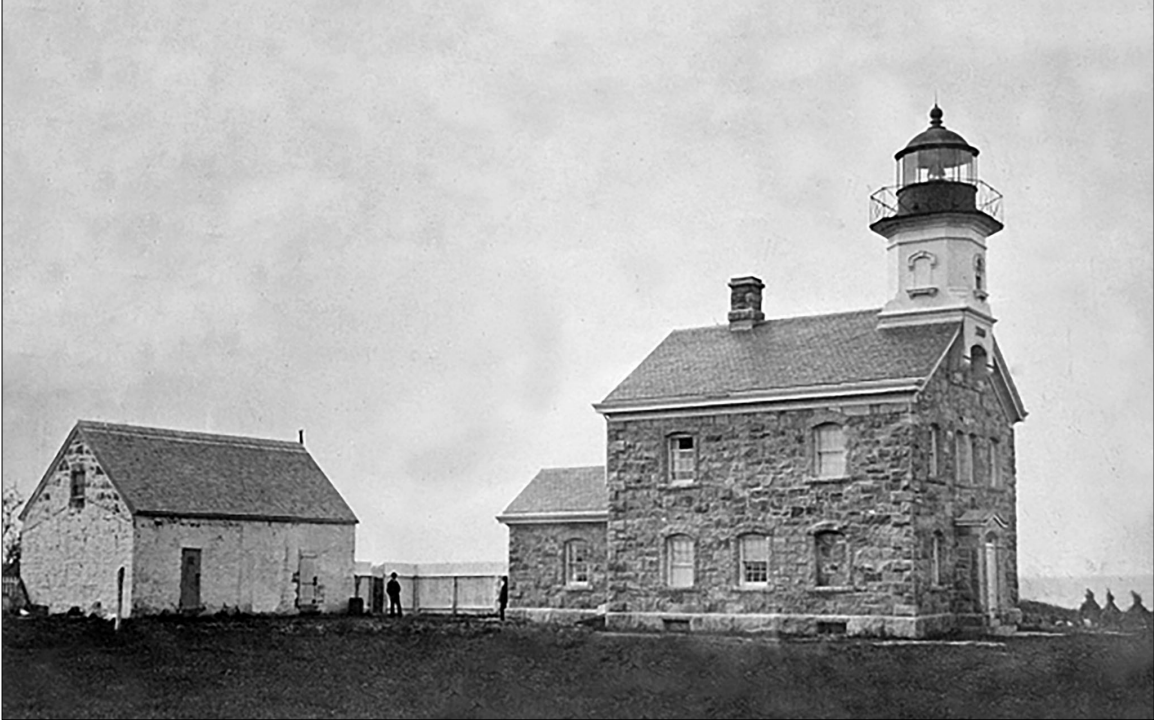
Image 5. Old Field Point Lighthouse, looking SW, c.1905.

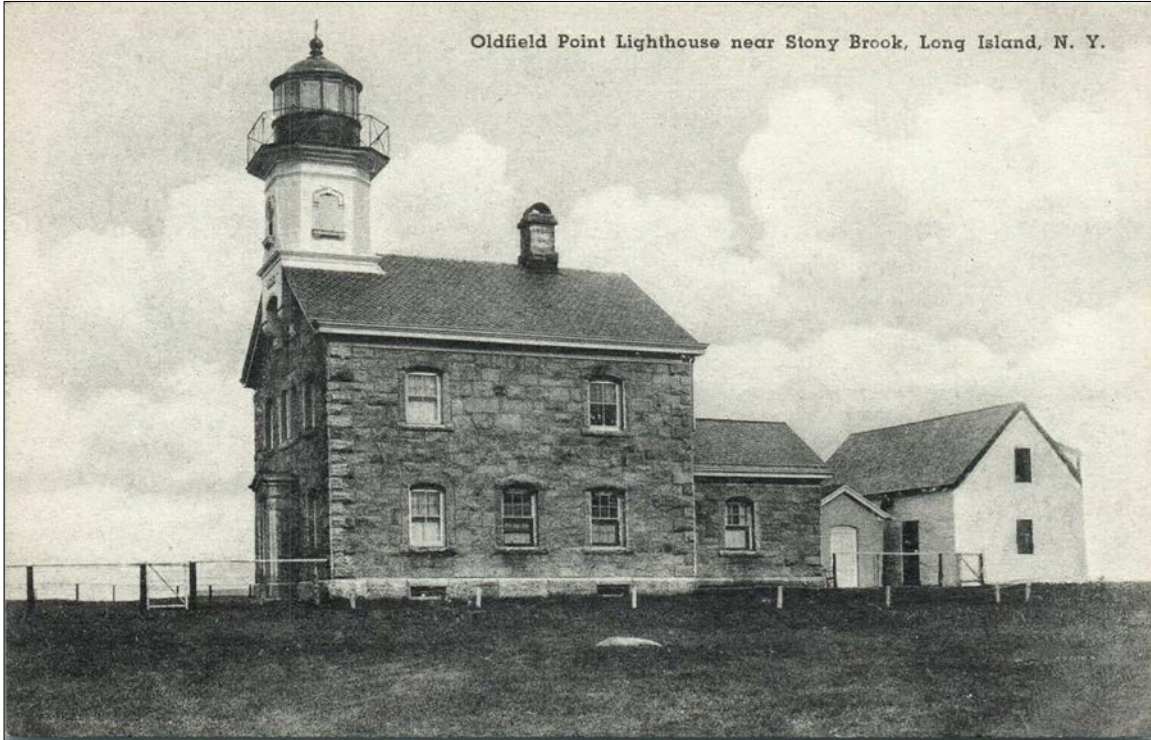
Image 6. Old Field Point Lighthouse, looking ESE, c.1912.

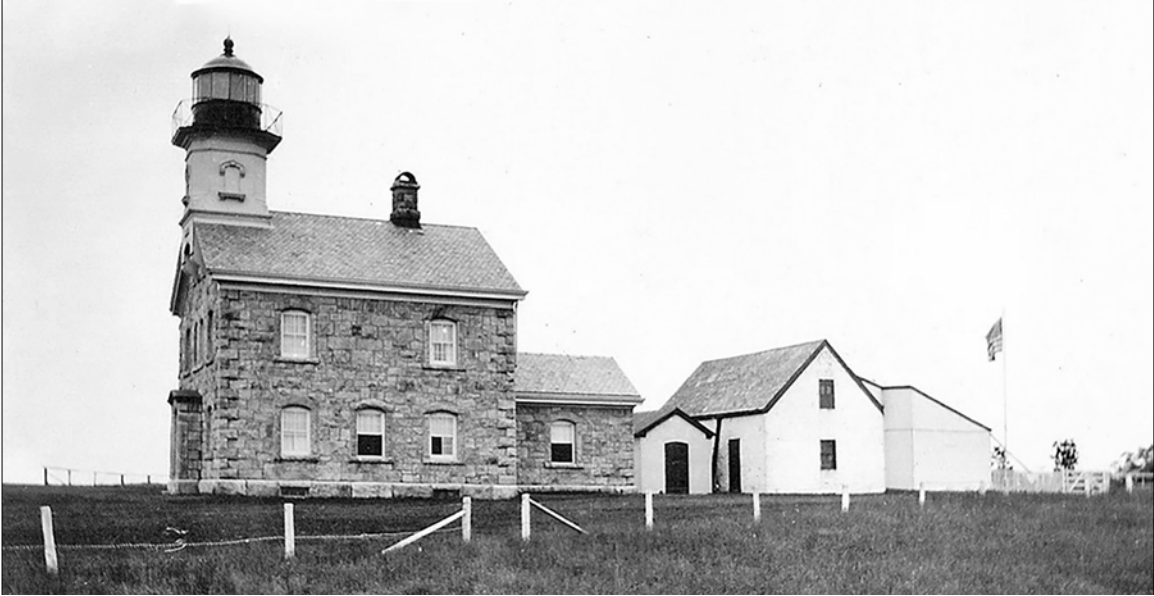
Image 7. Old Field Point Lighthouse, looking ESE, c.1930.

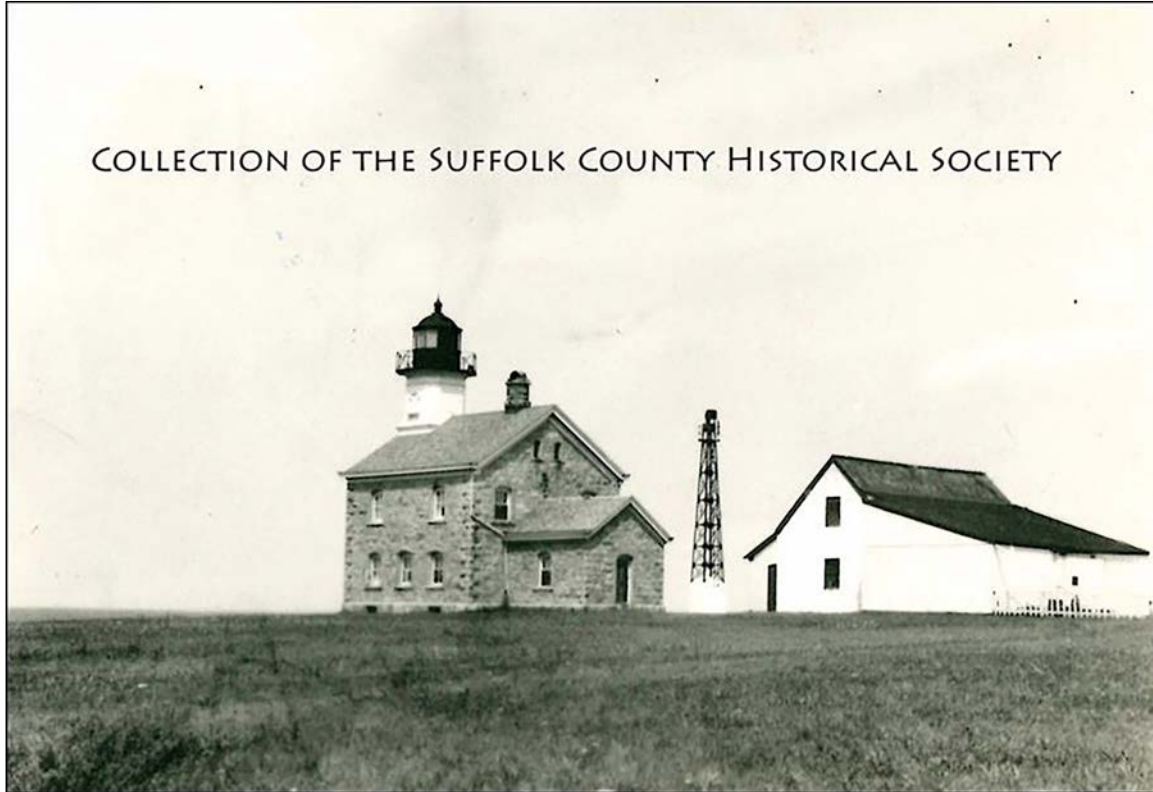
Image 8. Old Field Point Lighthouse, looking NE, c.1933. *Courtesy Suffolk County Historical Society.*

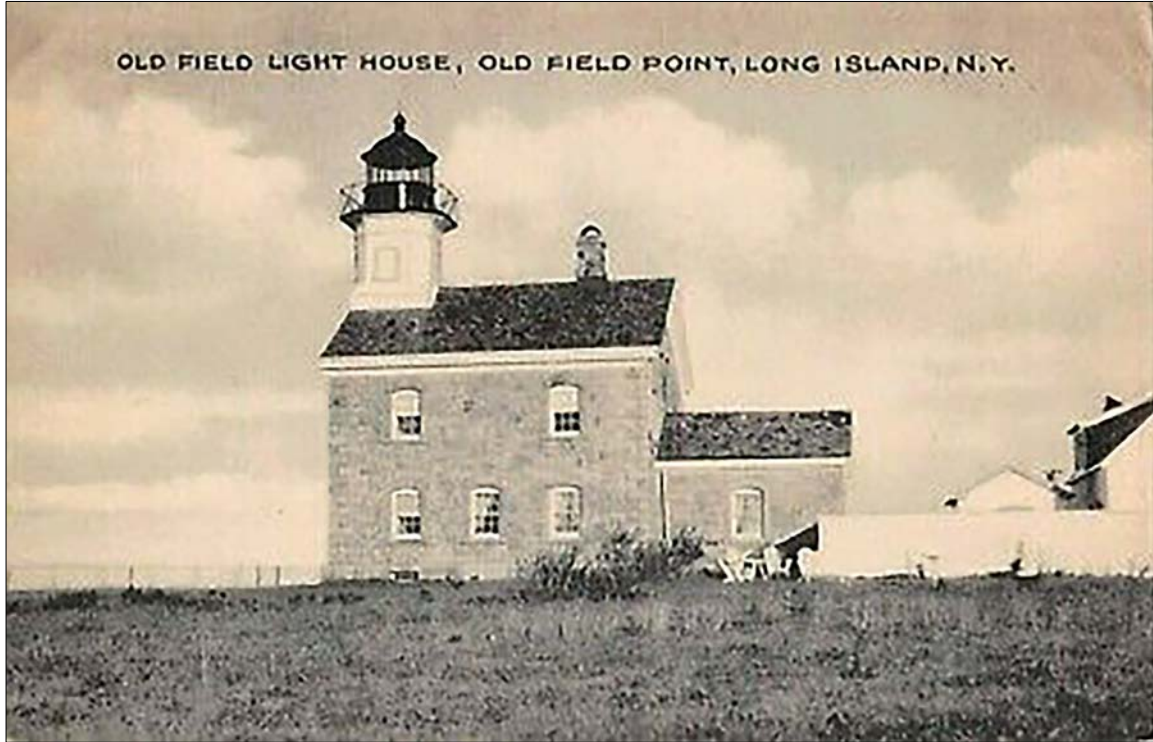
Image 9. Old Field Point Lighthouse, looking NE, c.1940.

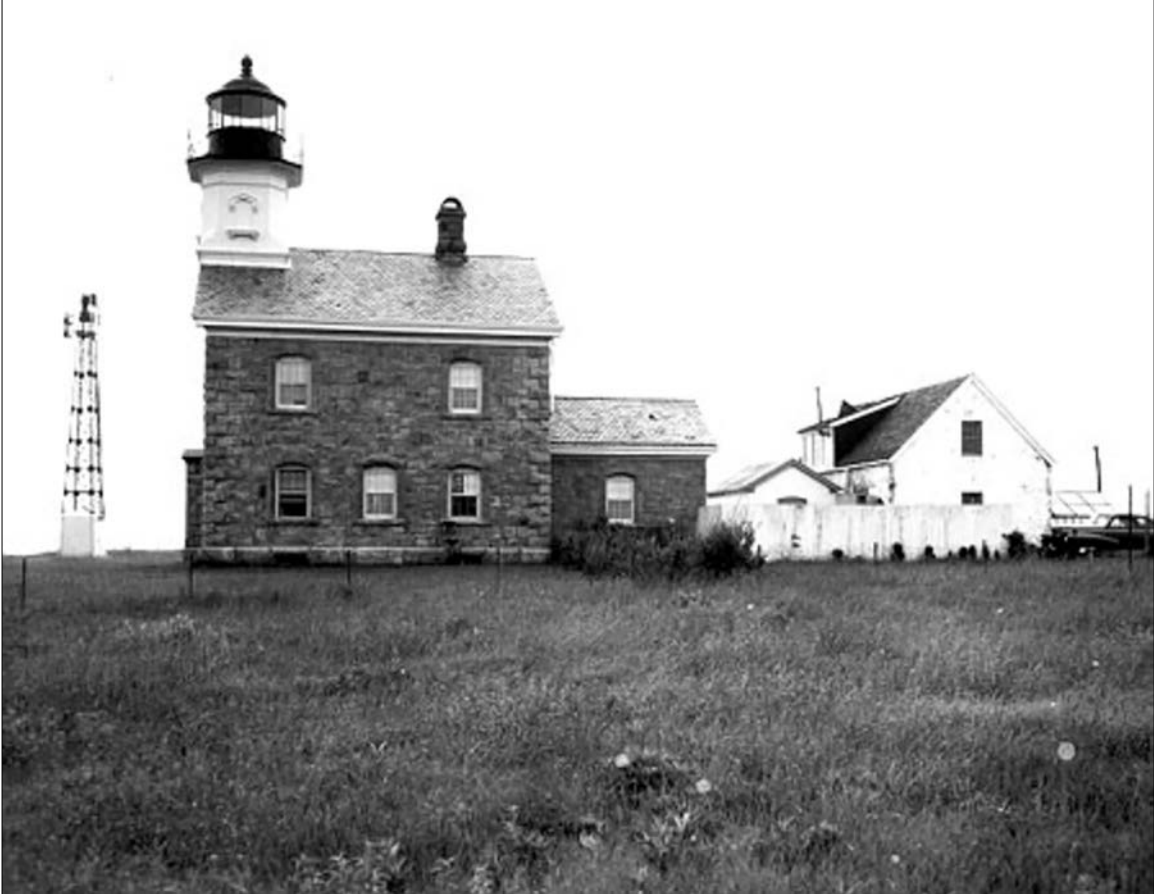
Image 10. Old Field Point Lighthouse, Looking E, c.1942. *Courtesy US Coast Guard Archives.*
